***May 12, 2008 Sichuan, China  
Earthquake Reconnaissance***

Zhenming Wang  
Kentucky Geological Survey  
228 MMRB

July 2008

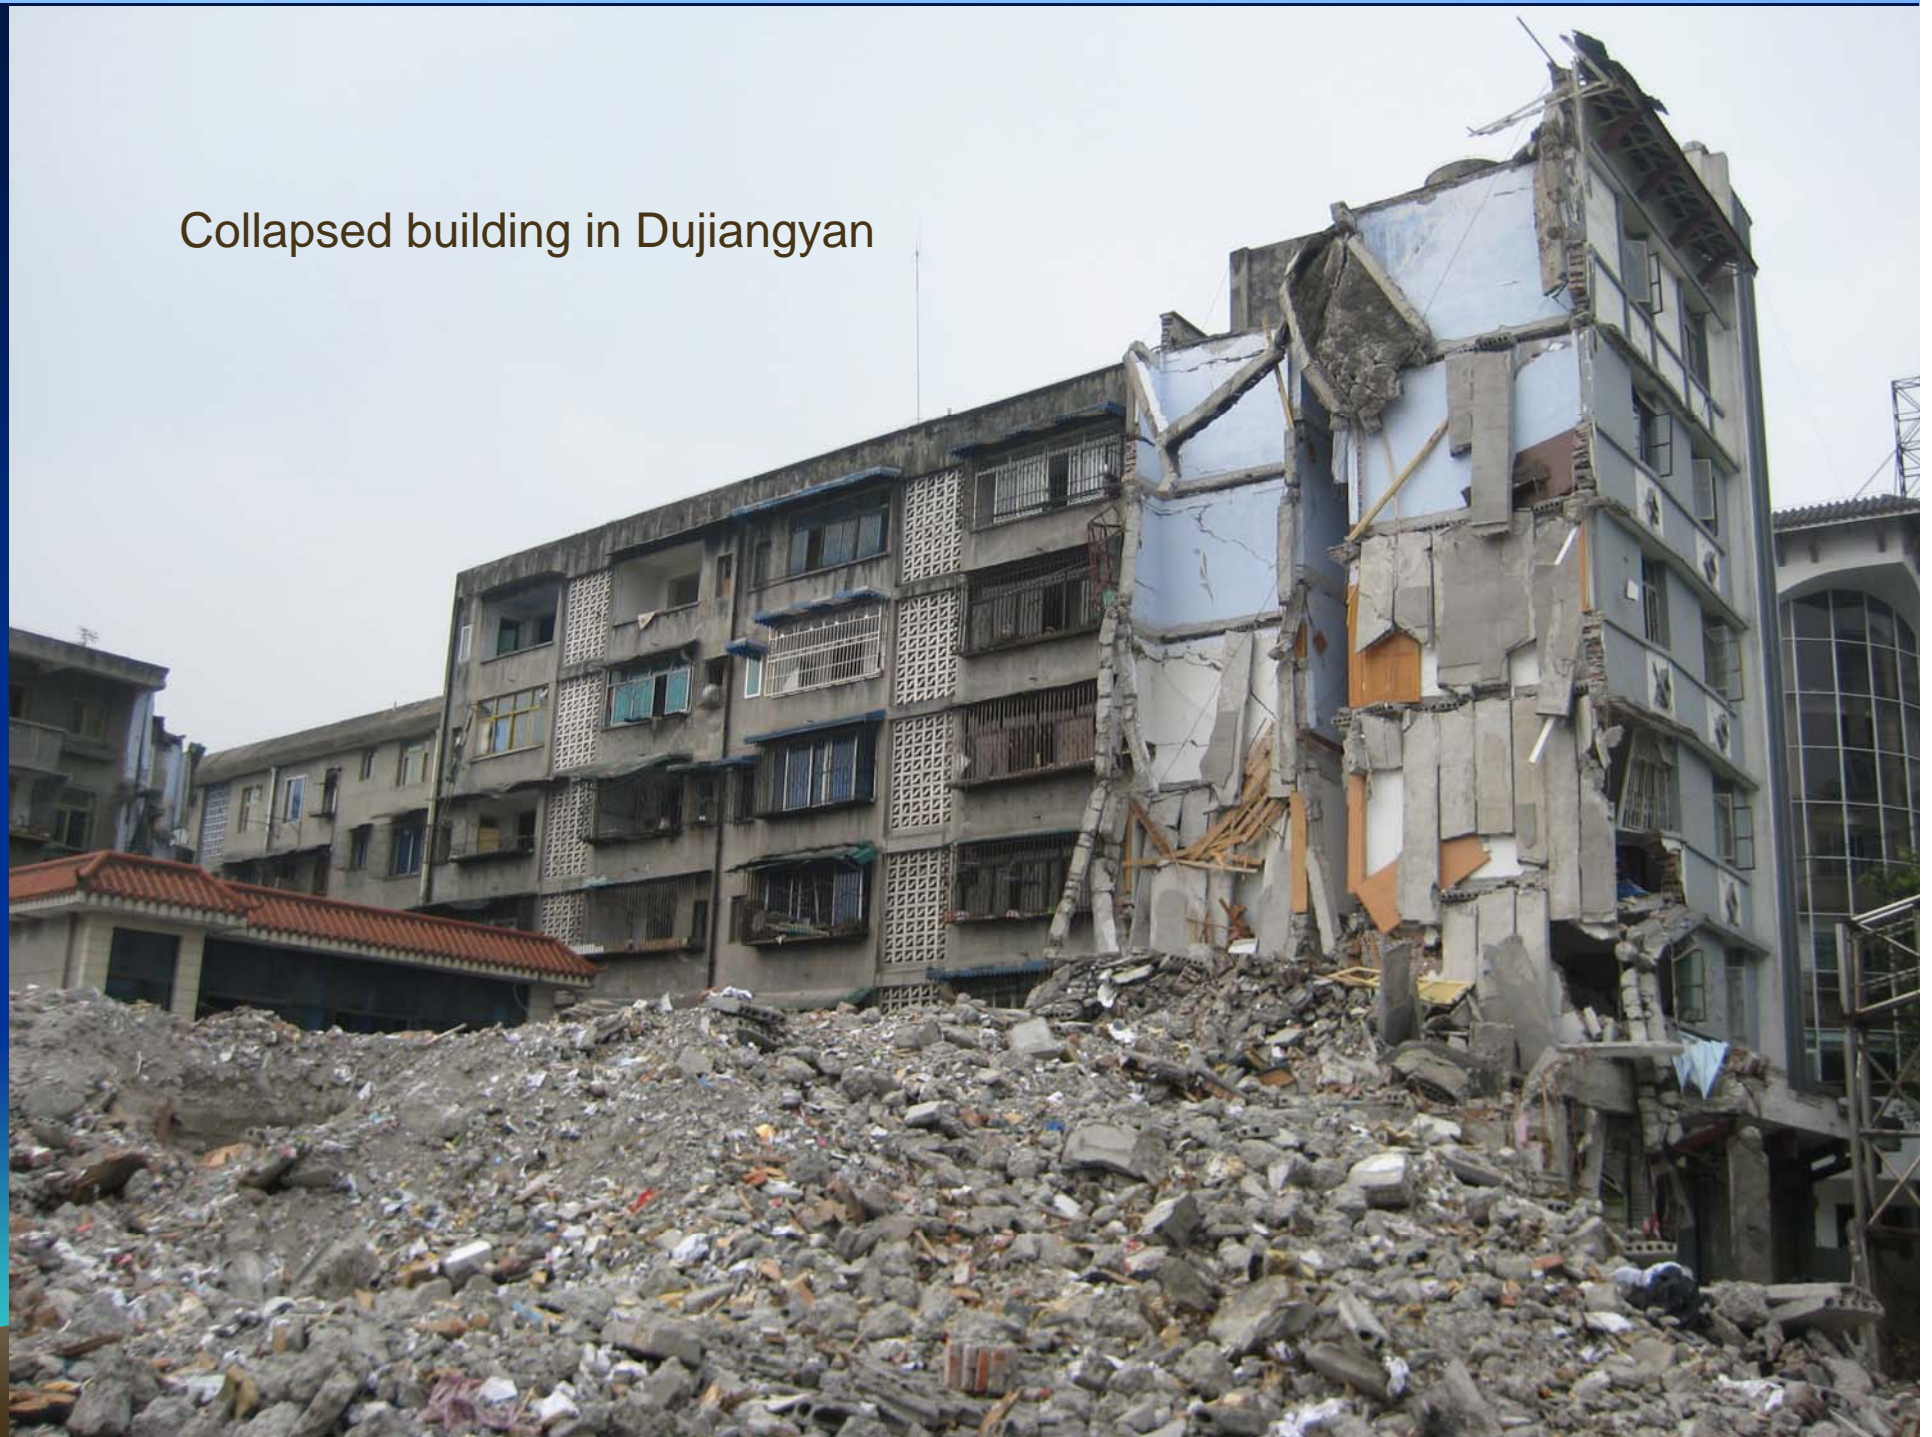
Collapsed building in Dujiangyan

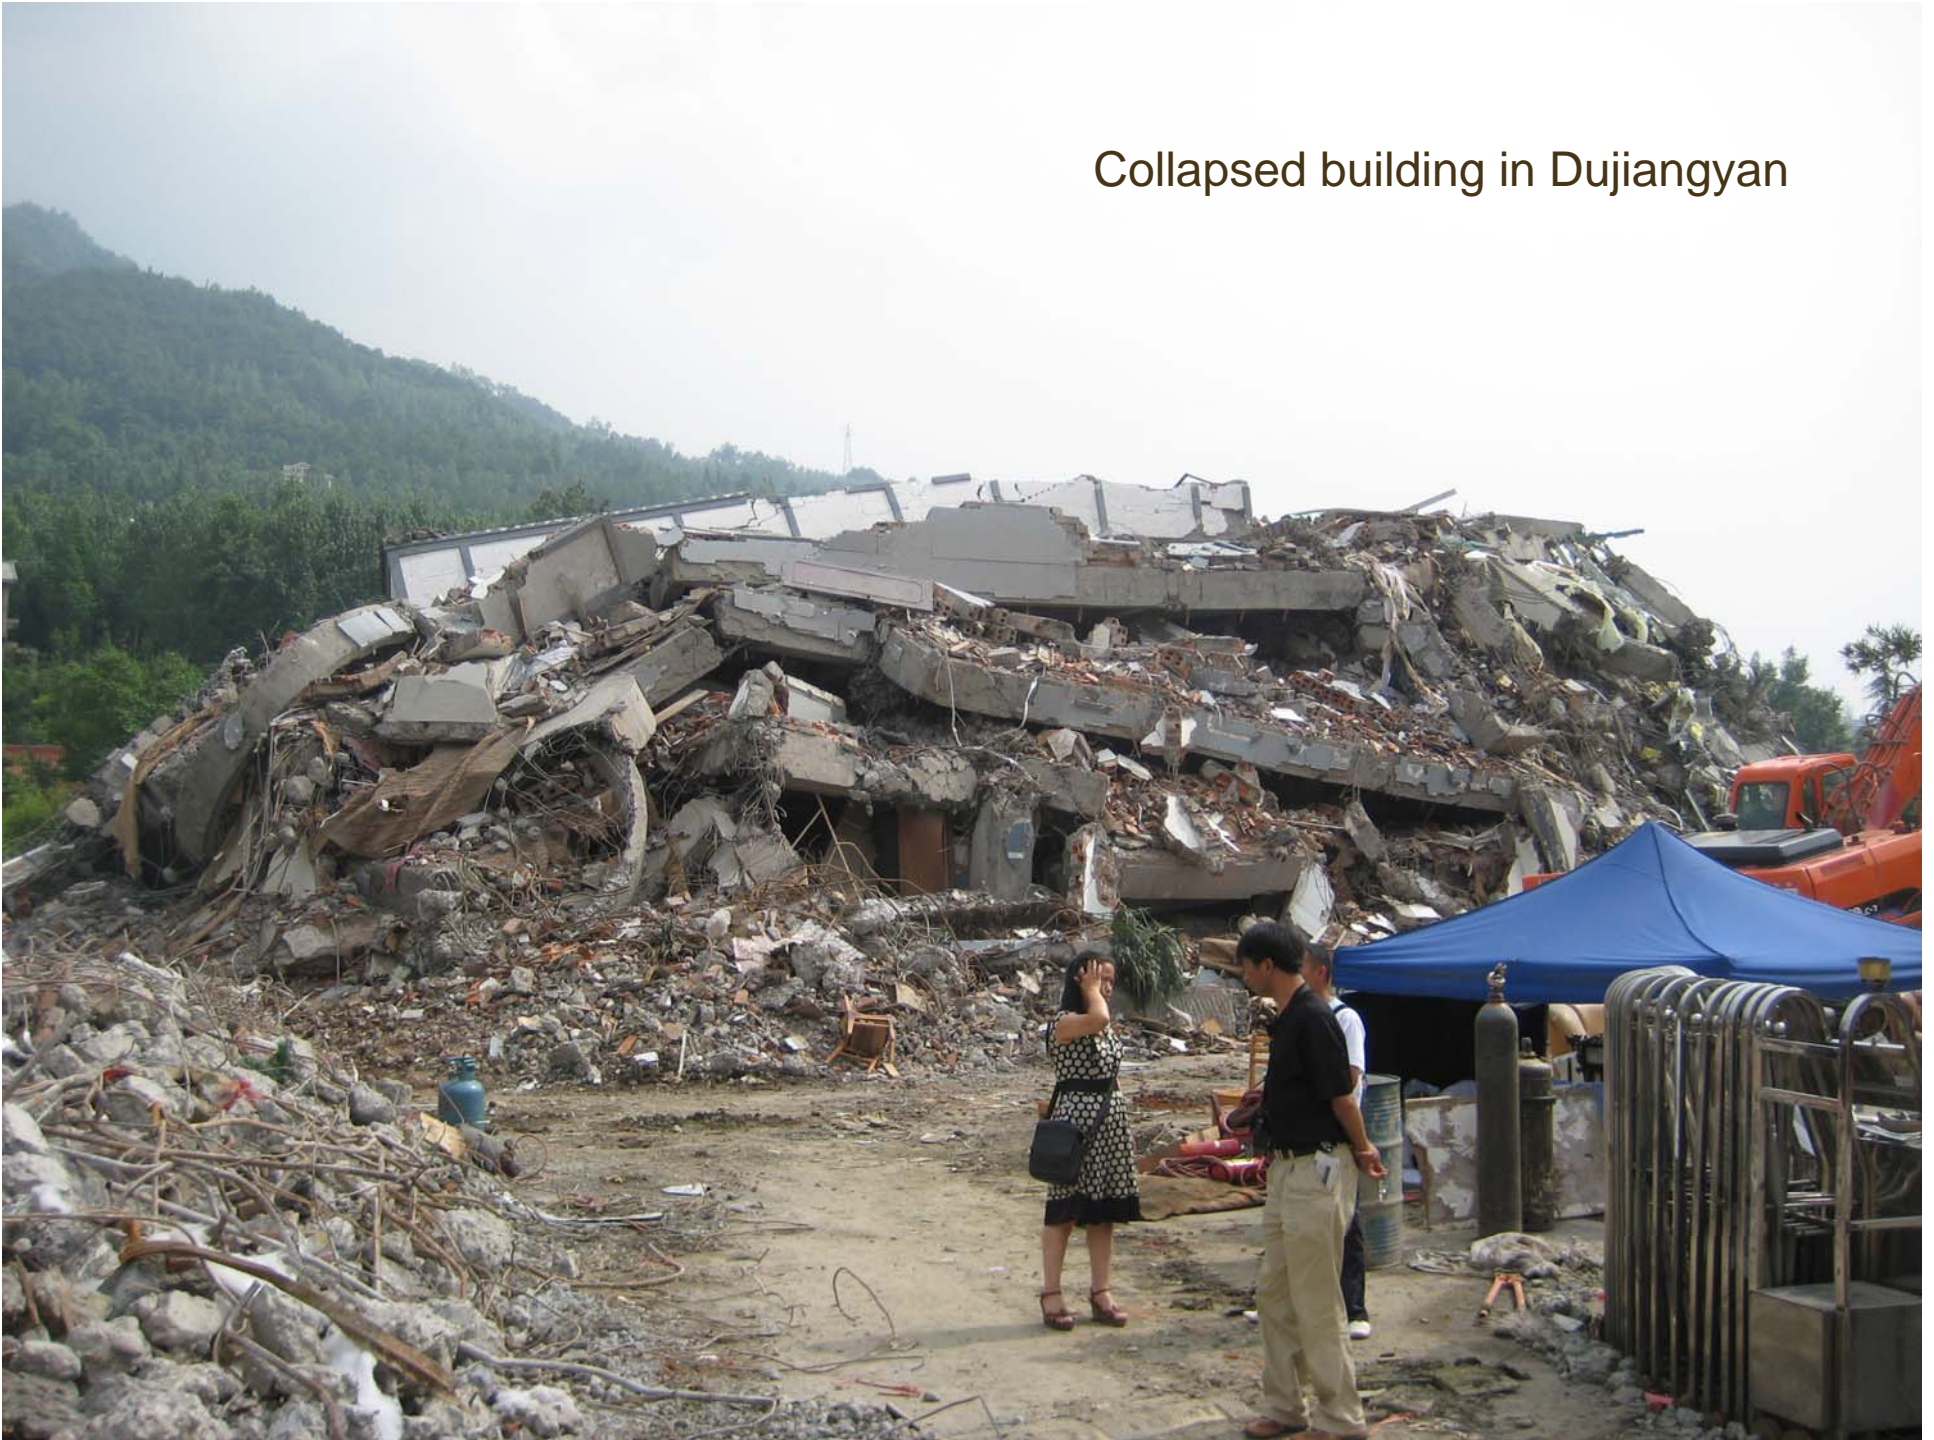
Collapsed building in Dujiangyan

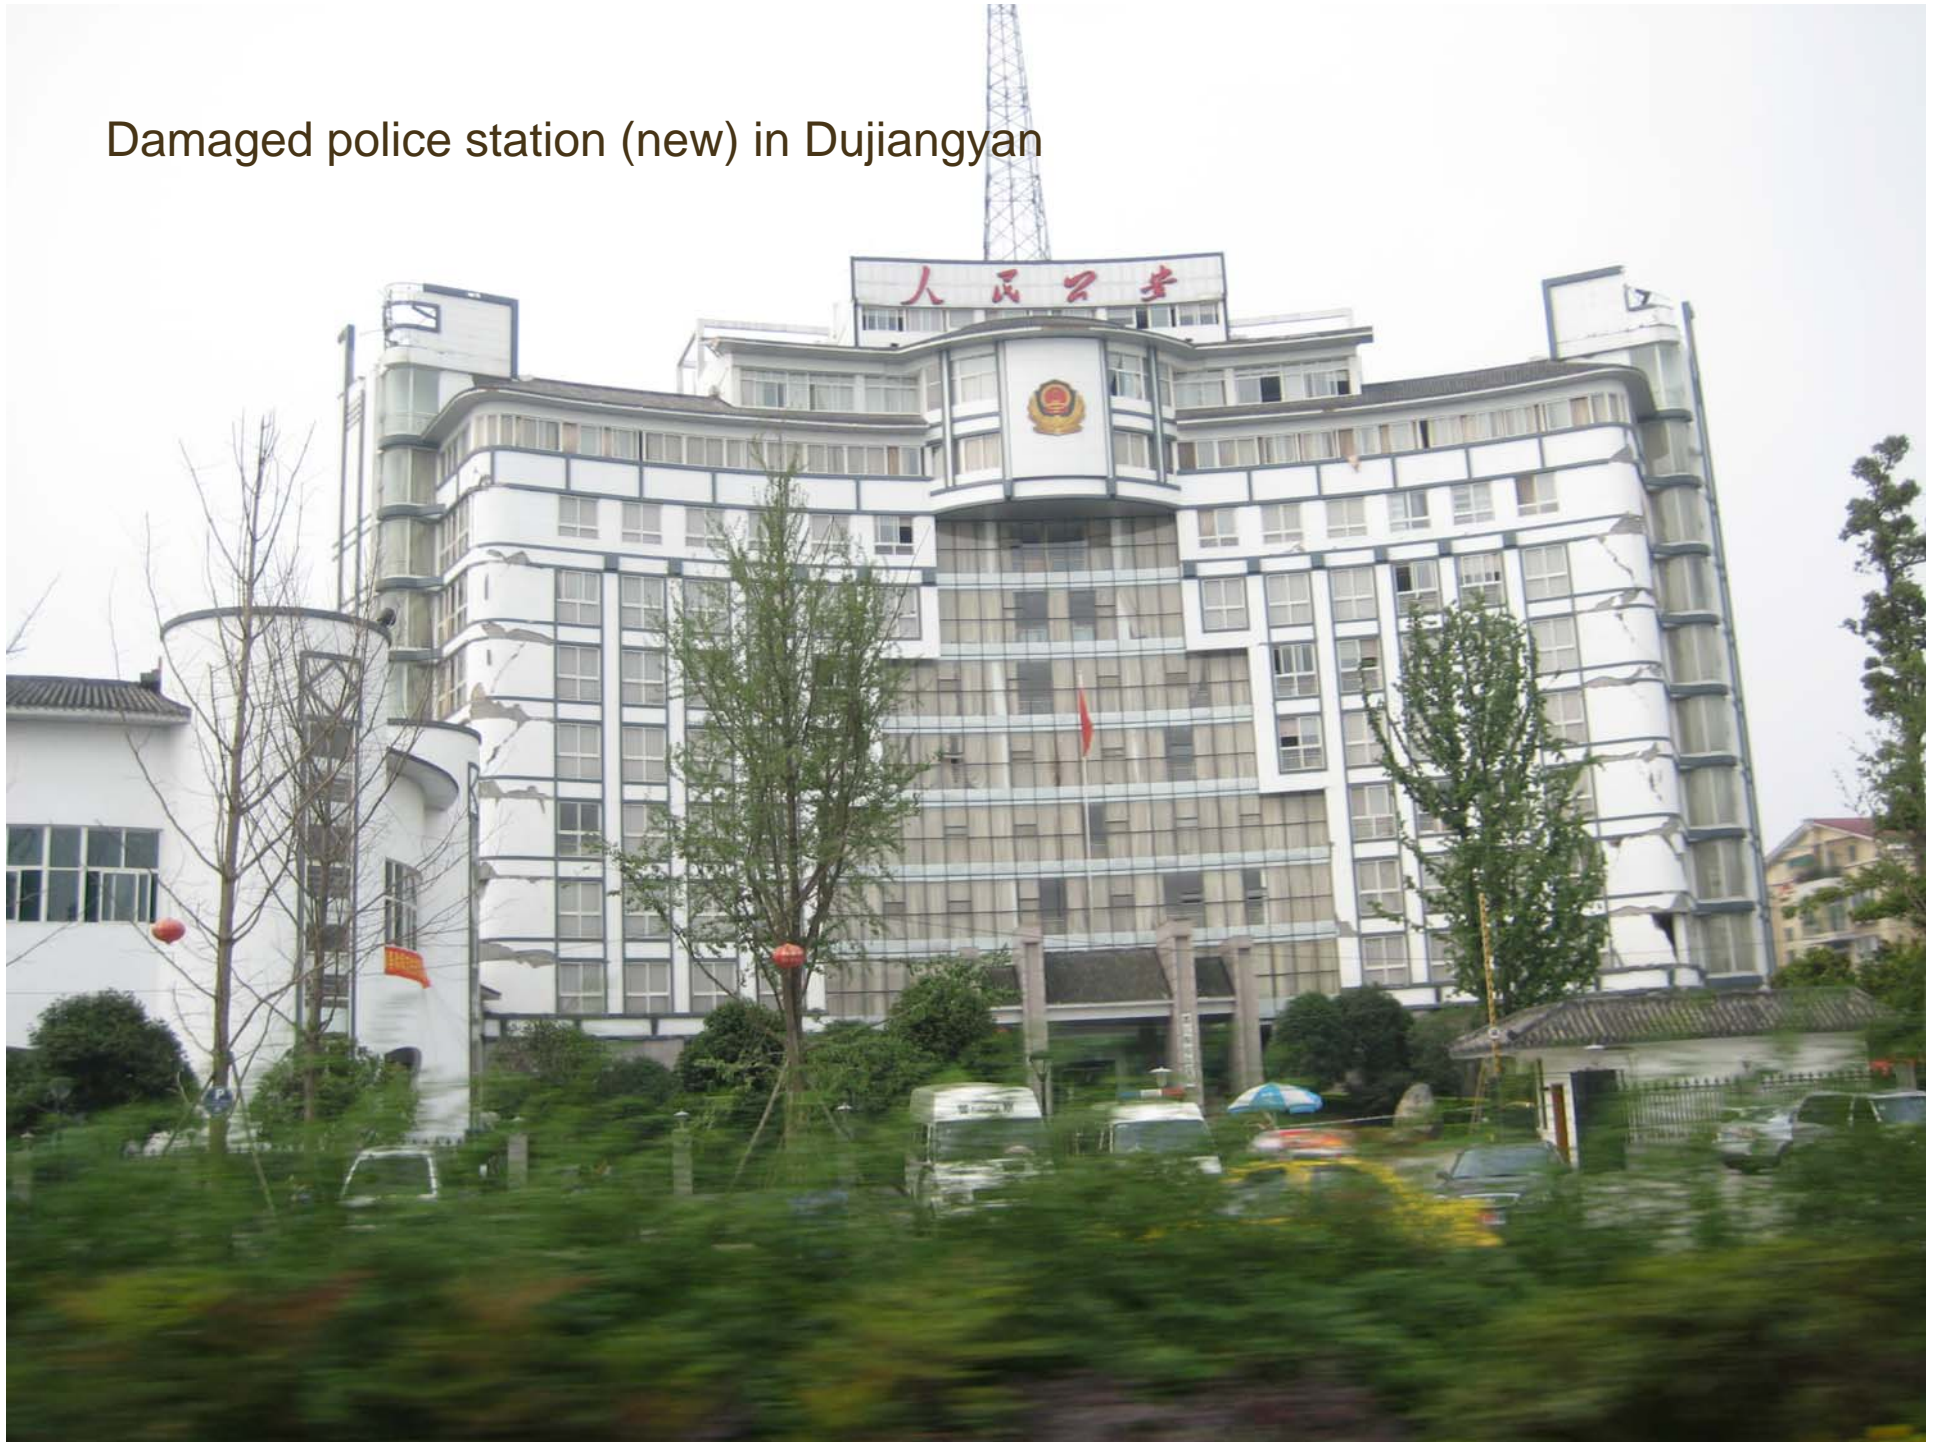
Damaged police station (new) in Dujiangyan

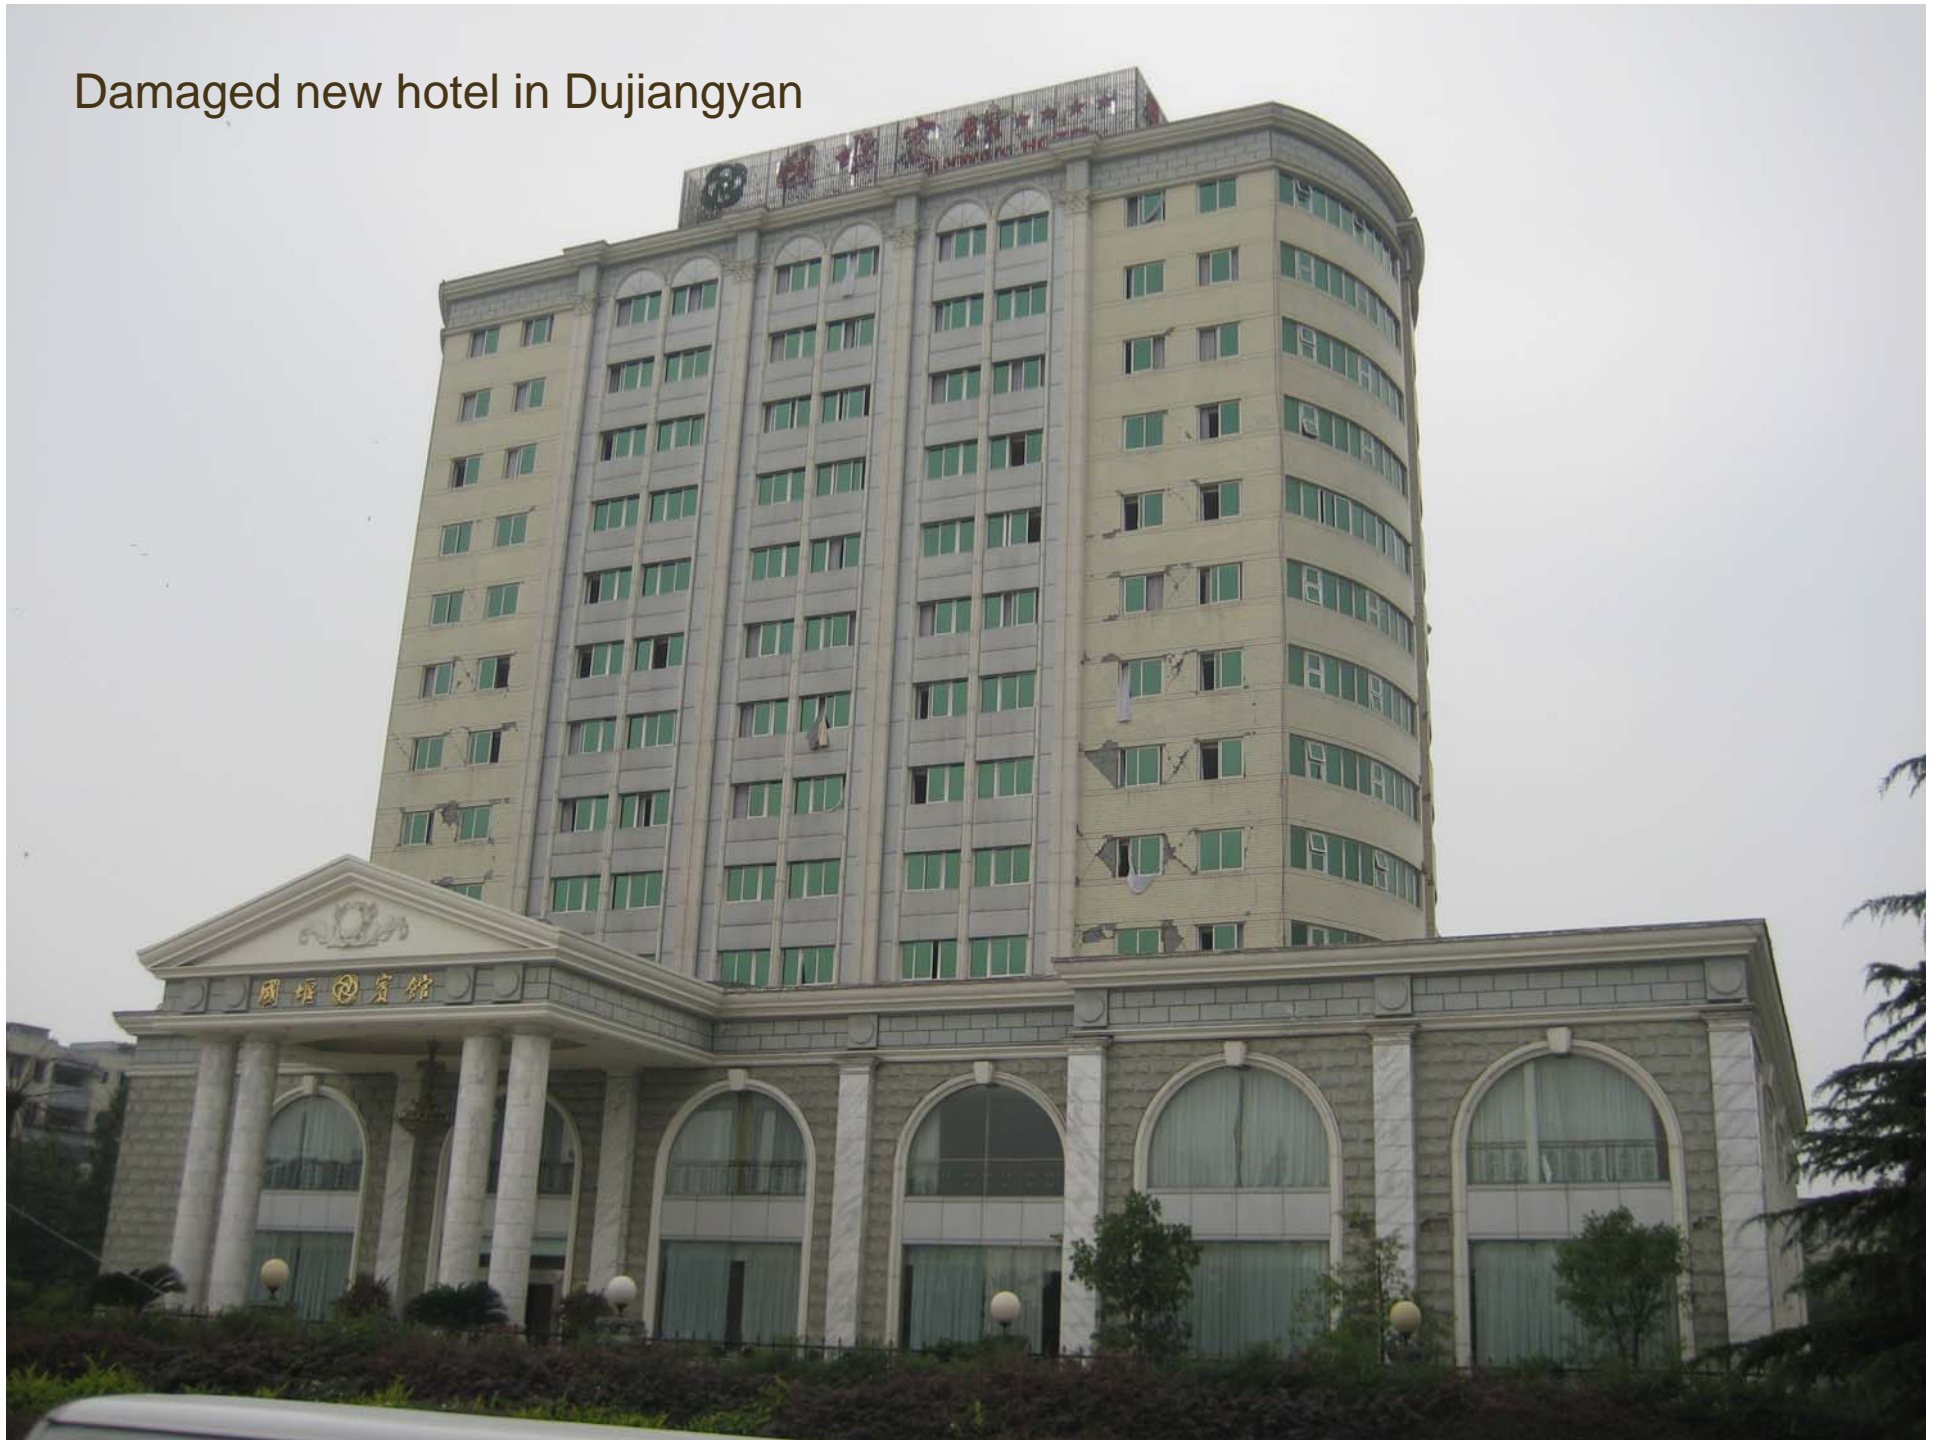
Damaged new hotel in Dujiangyan

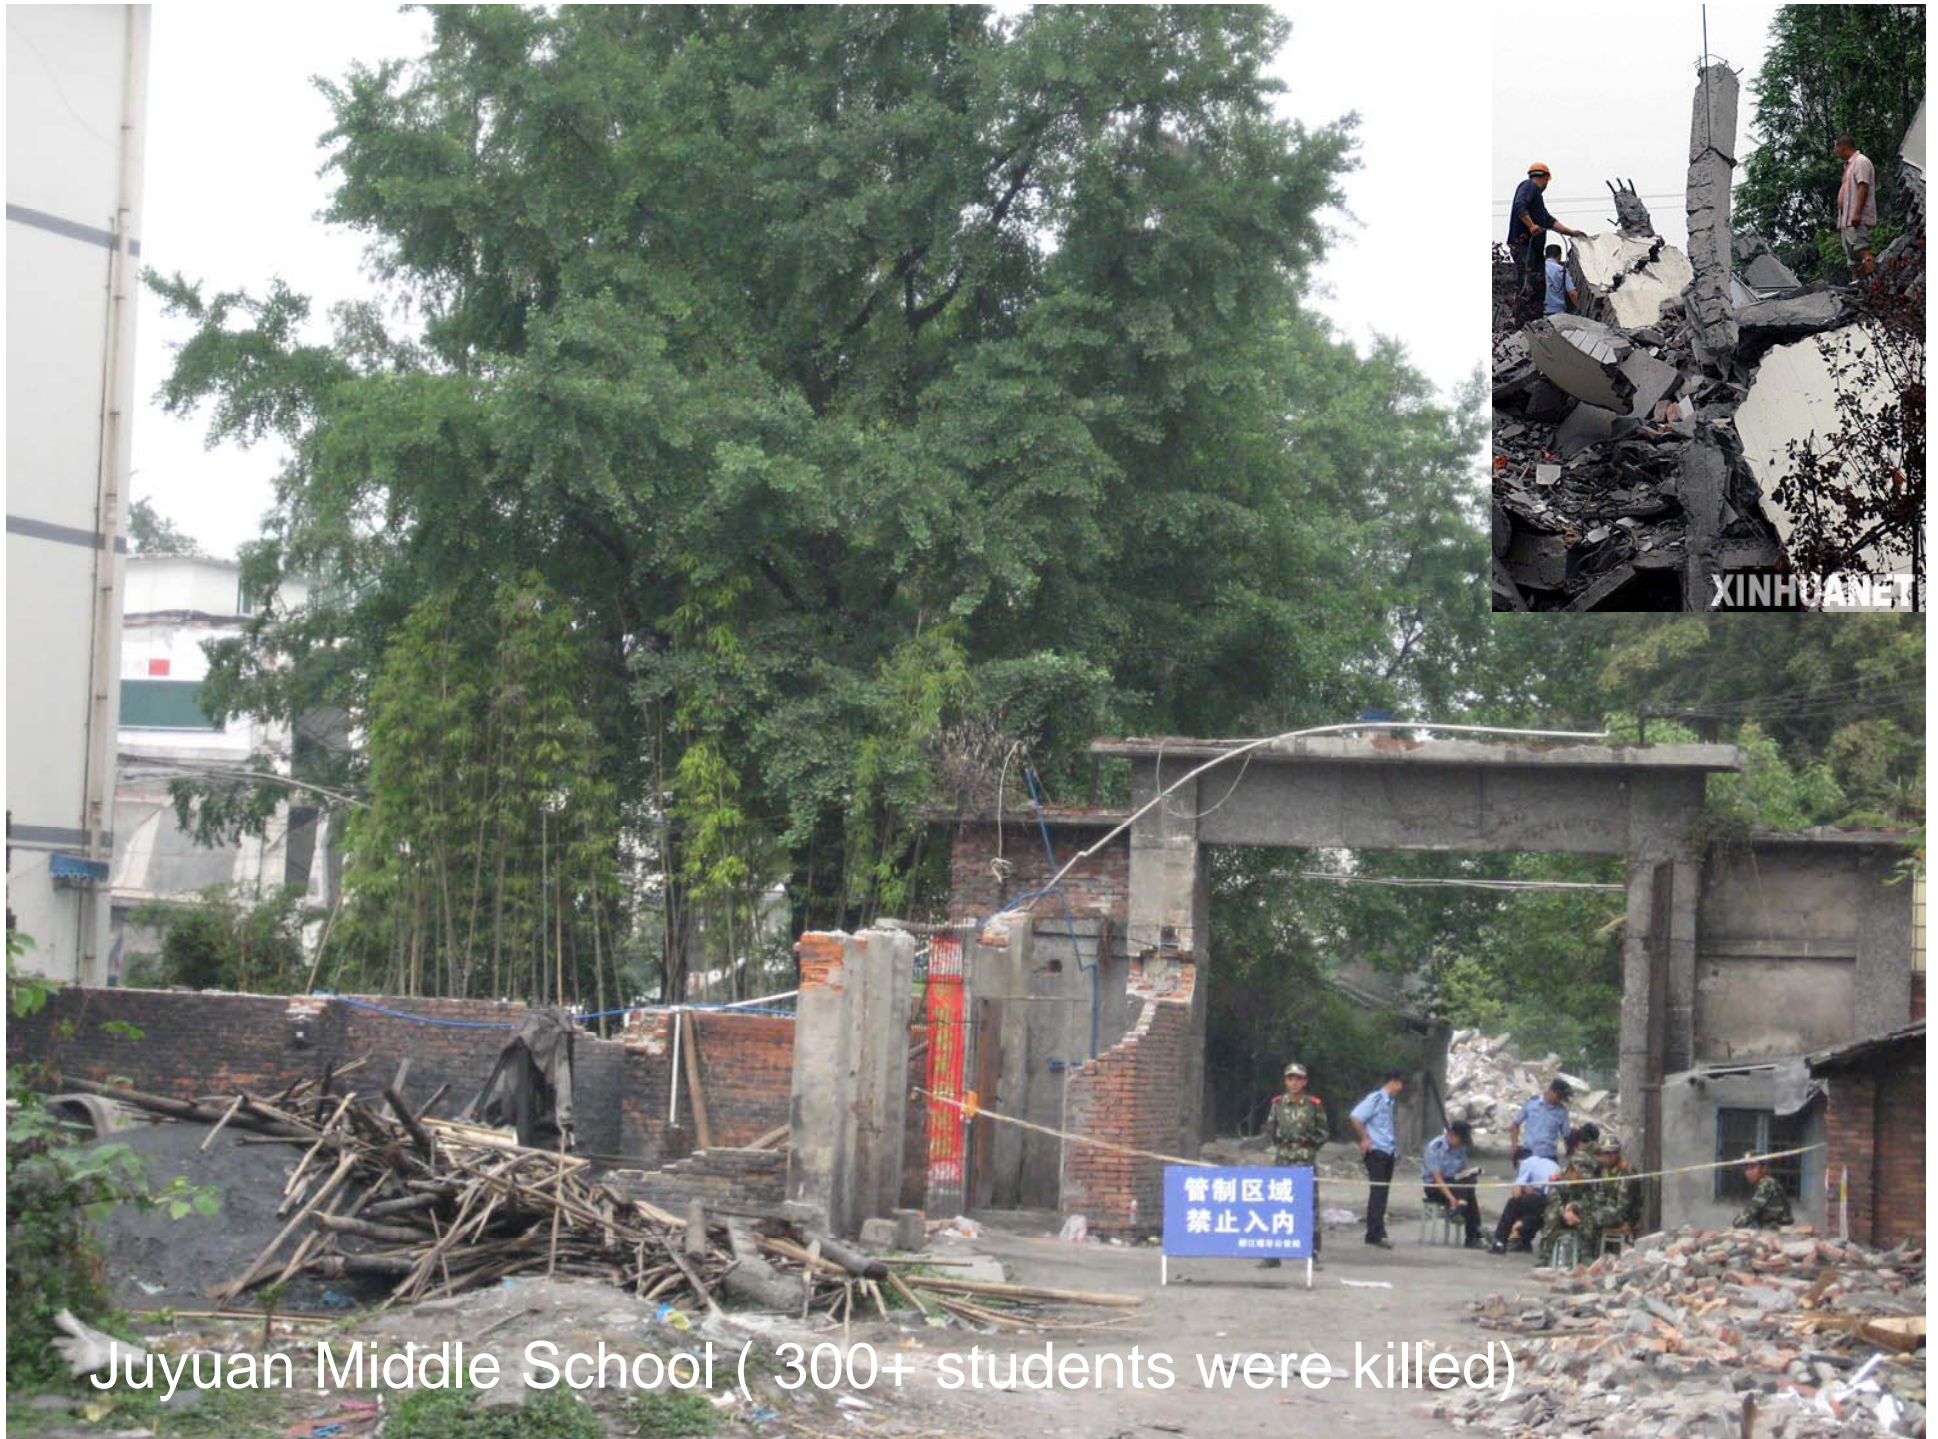
Juyuan Middle School ( 300+ students were killed)

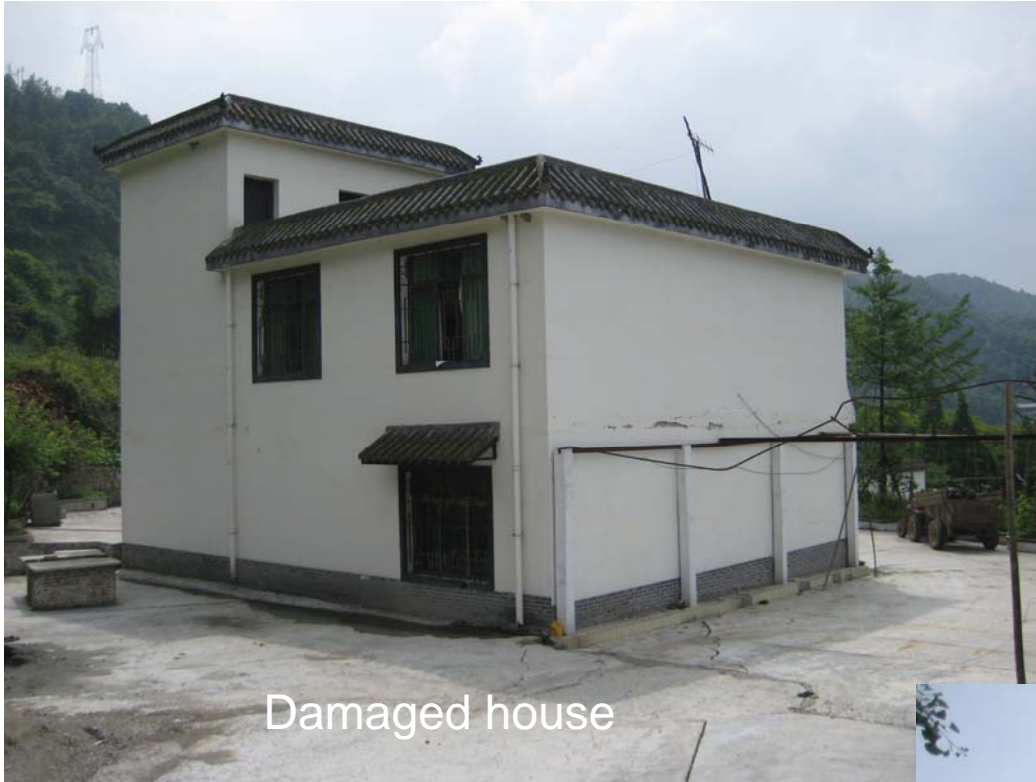
Damaged house

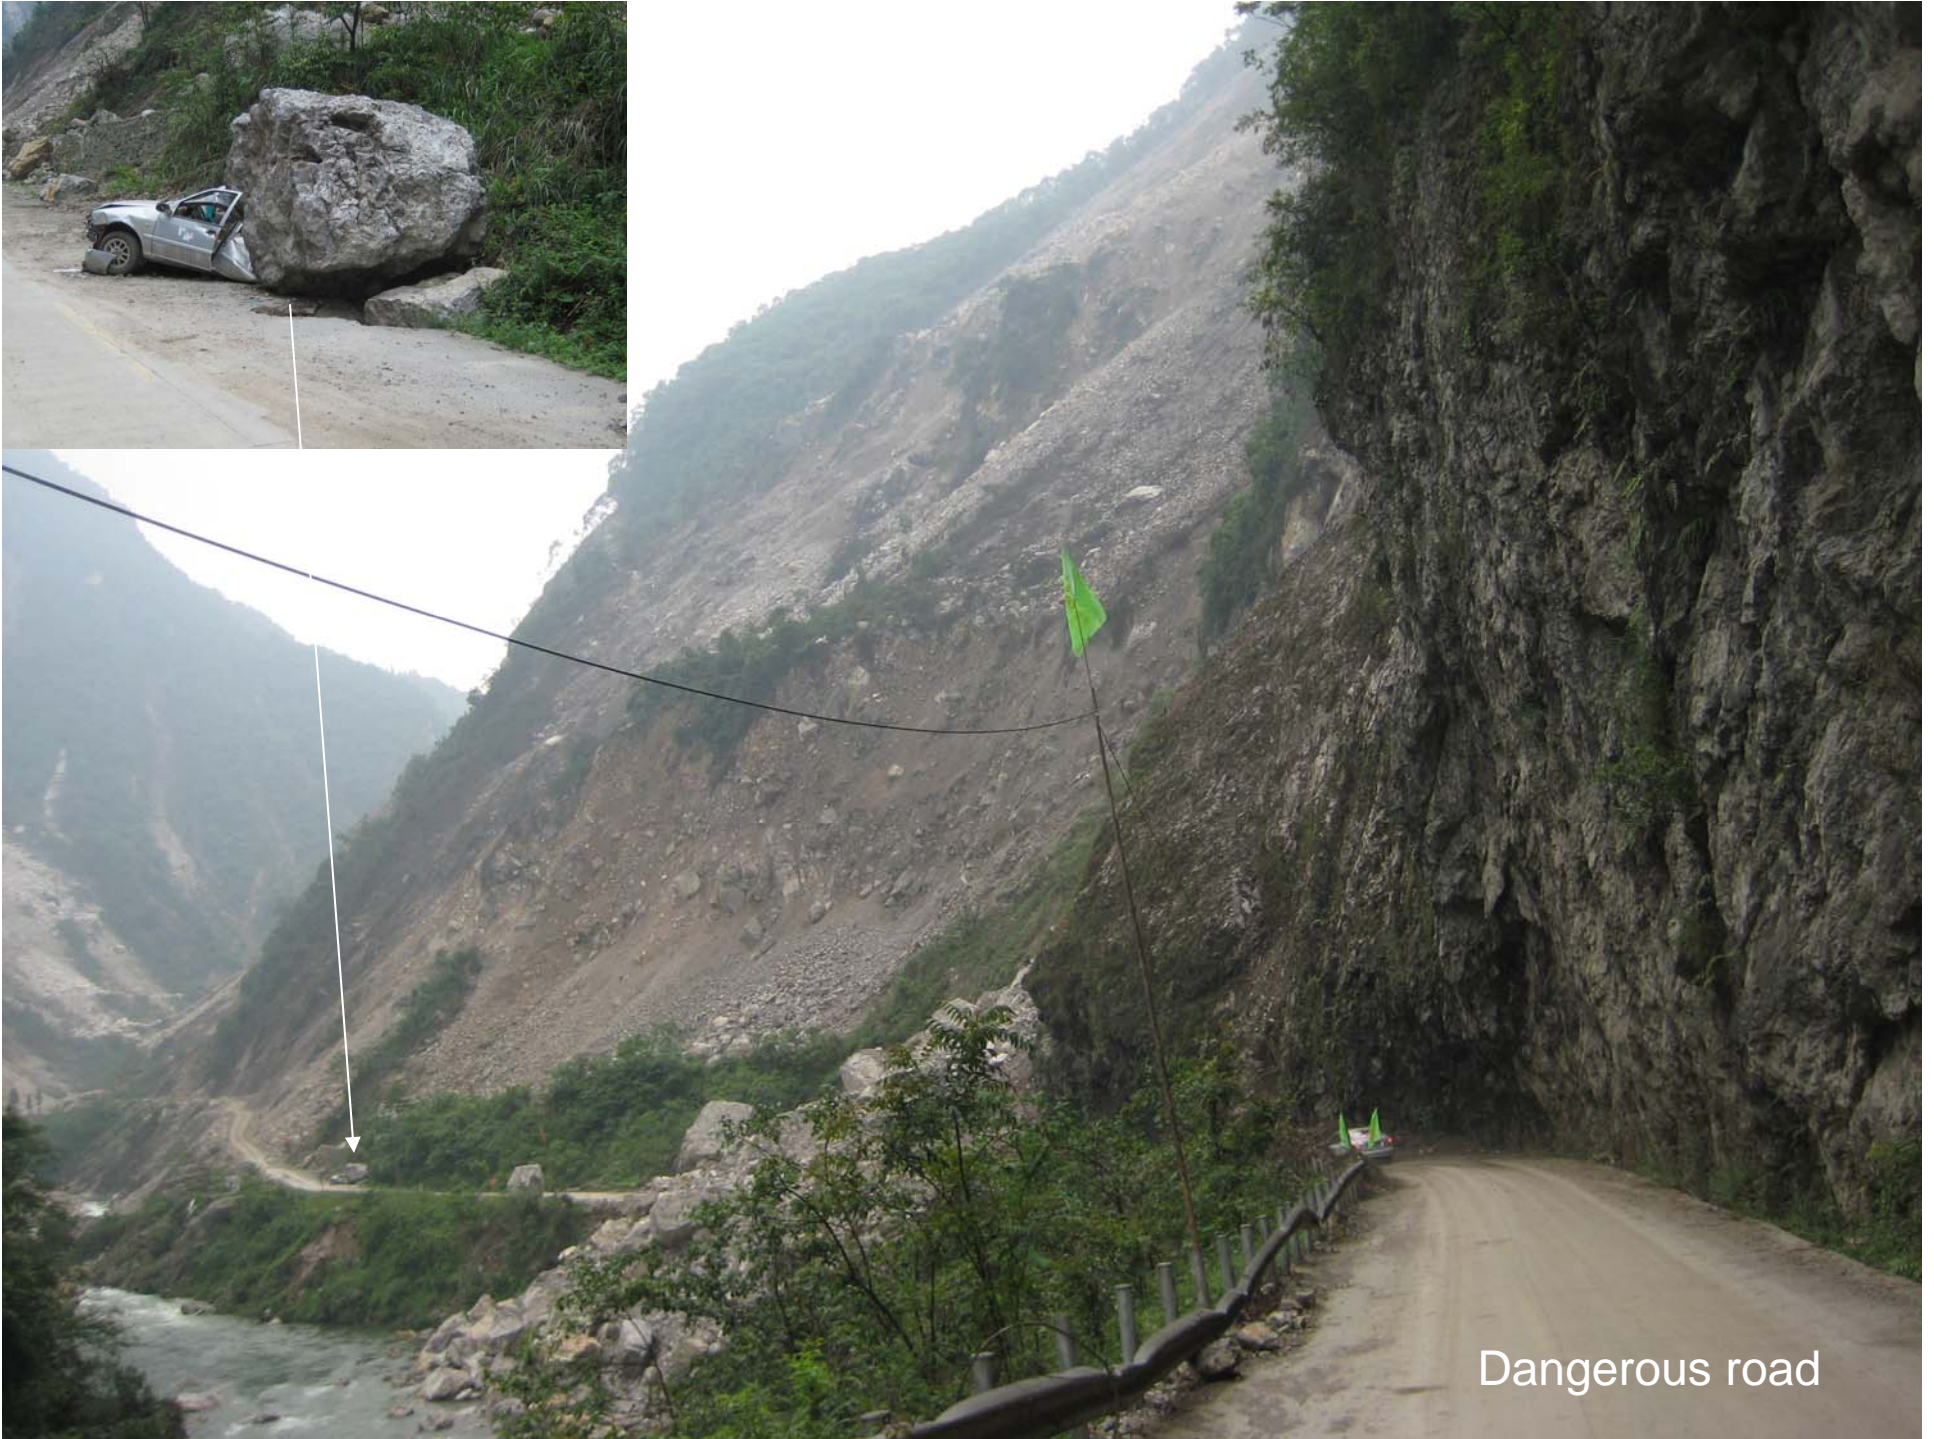
Dangerous road

Damaged bridge

Lateral spreading

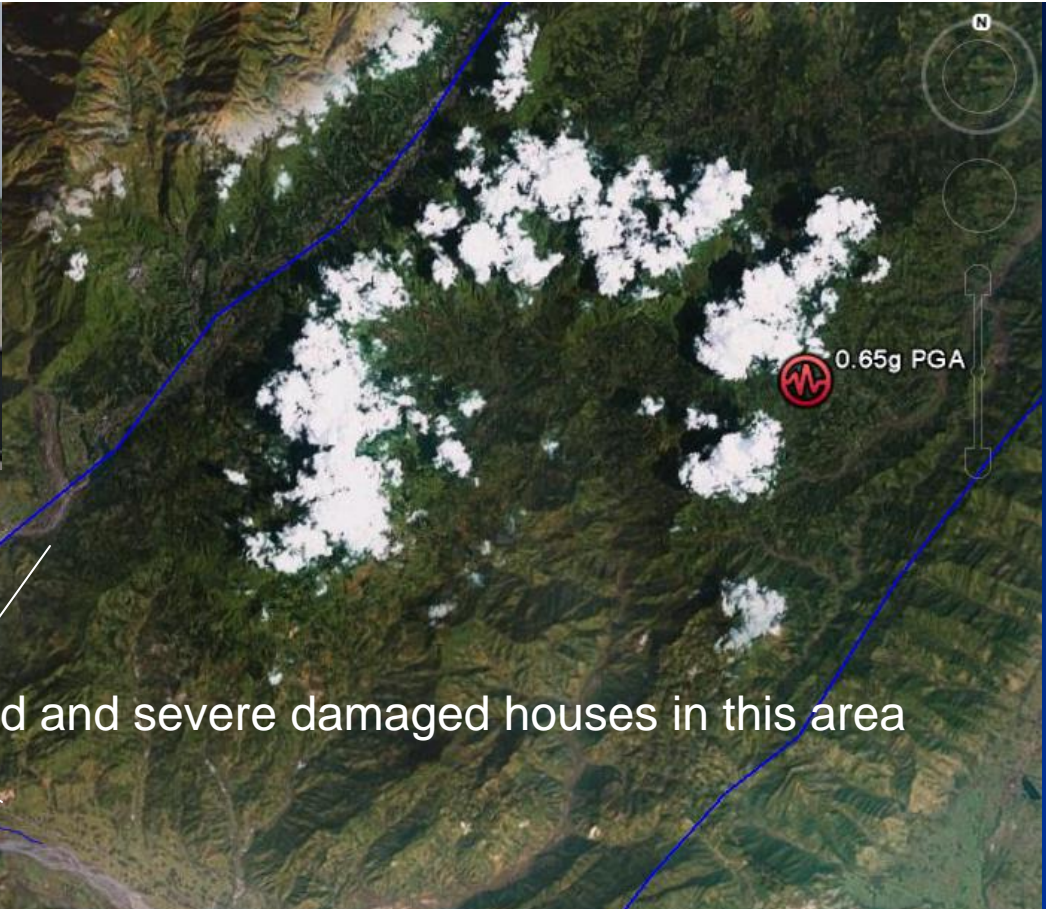
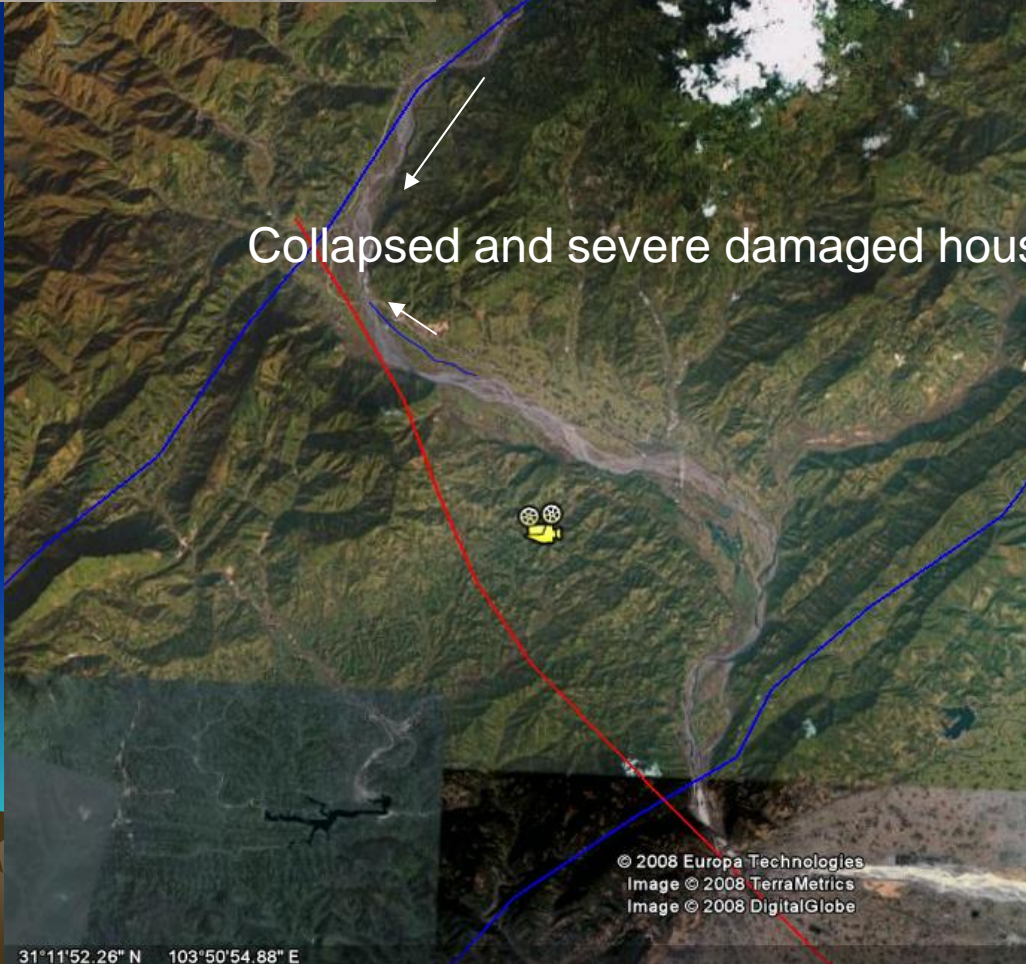
Collapsed and severe damaged houses in this area

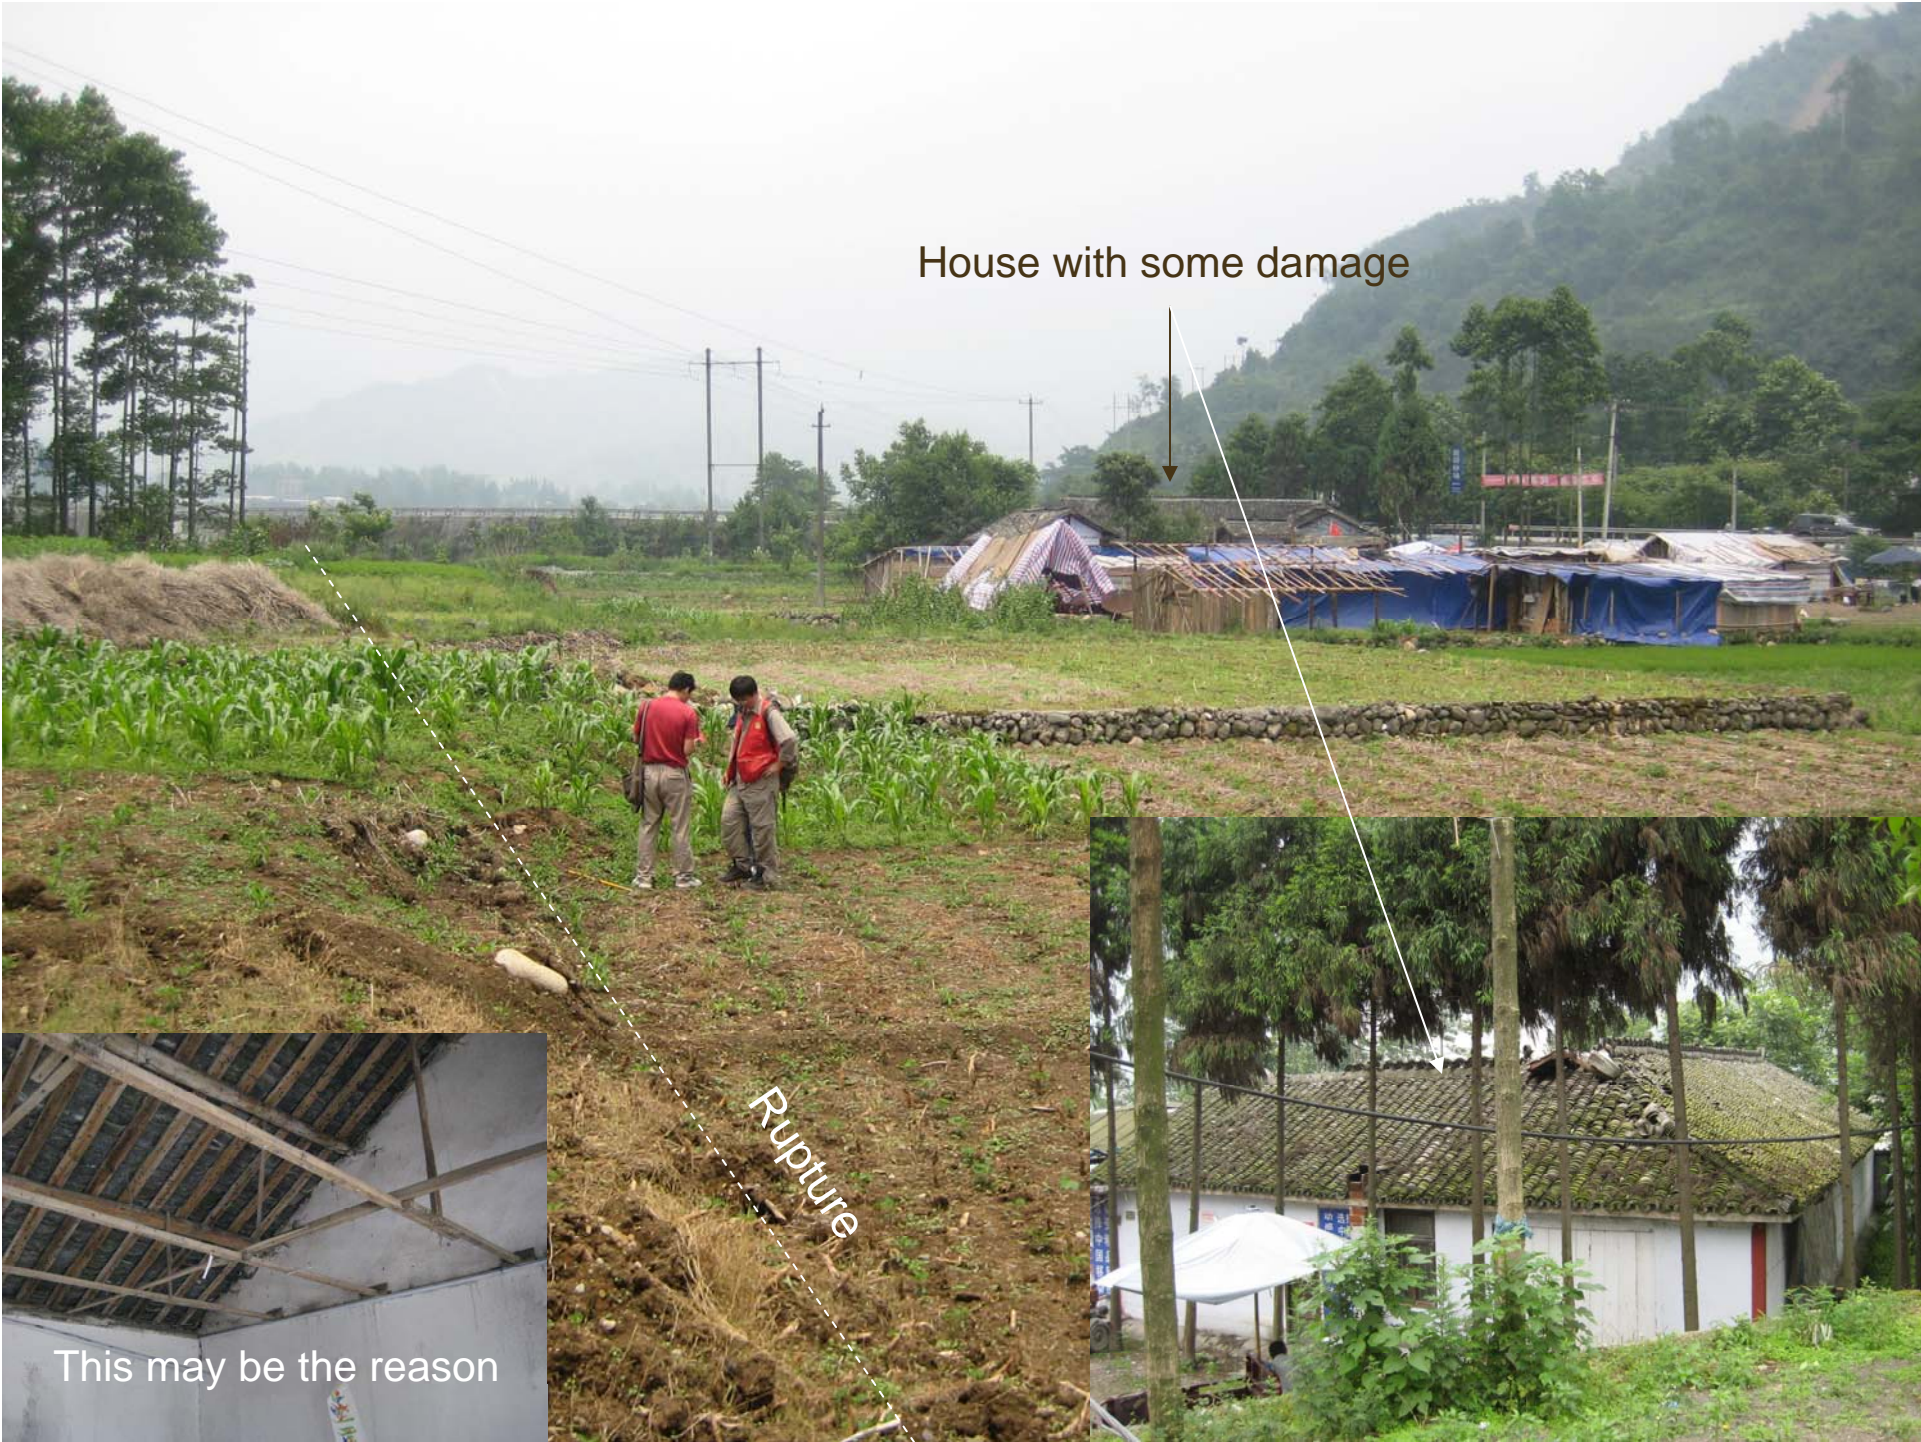
House with some damage

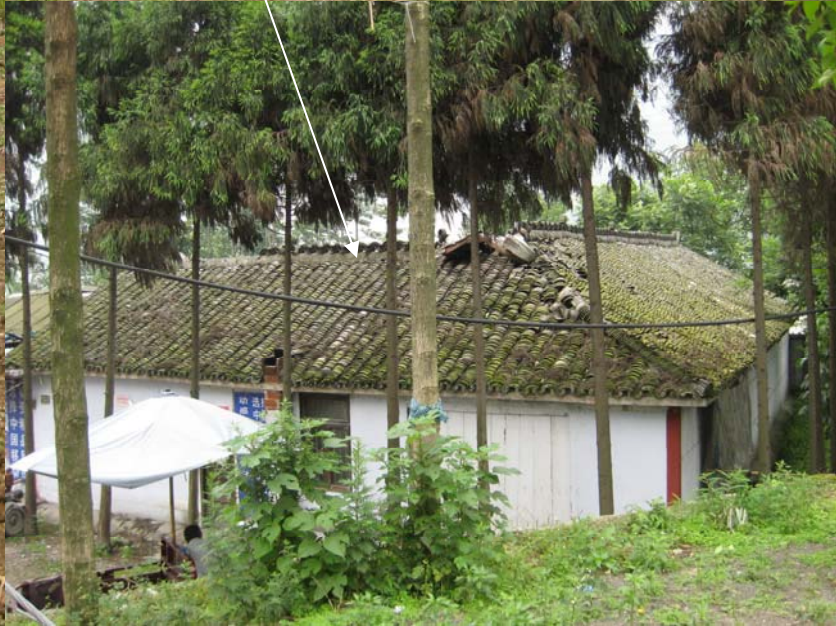
This may be the reason

Rupture
