***May 12, 2008 Sichuan, China  
Earthquake Reconnaissance***

Zhenming Wang  
Kentucky Geological Survey  
228 MMRB

July 2008

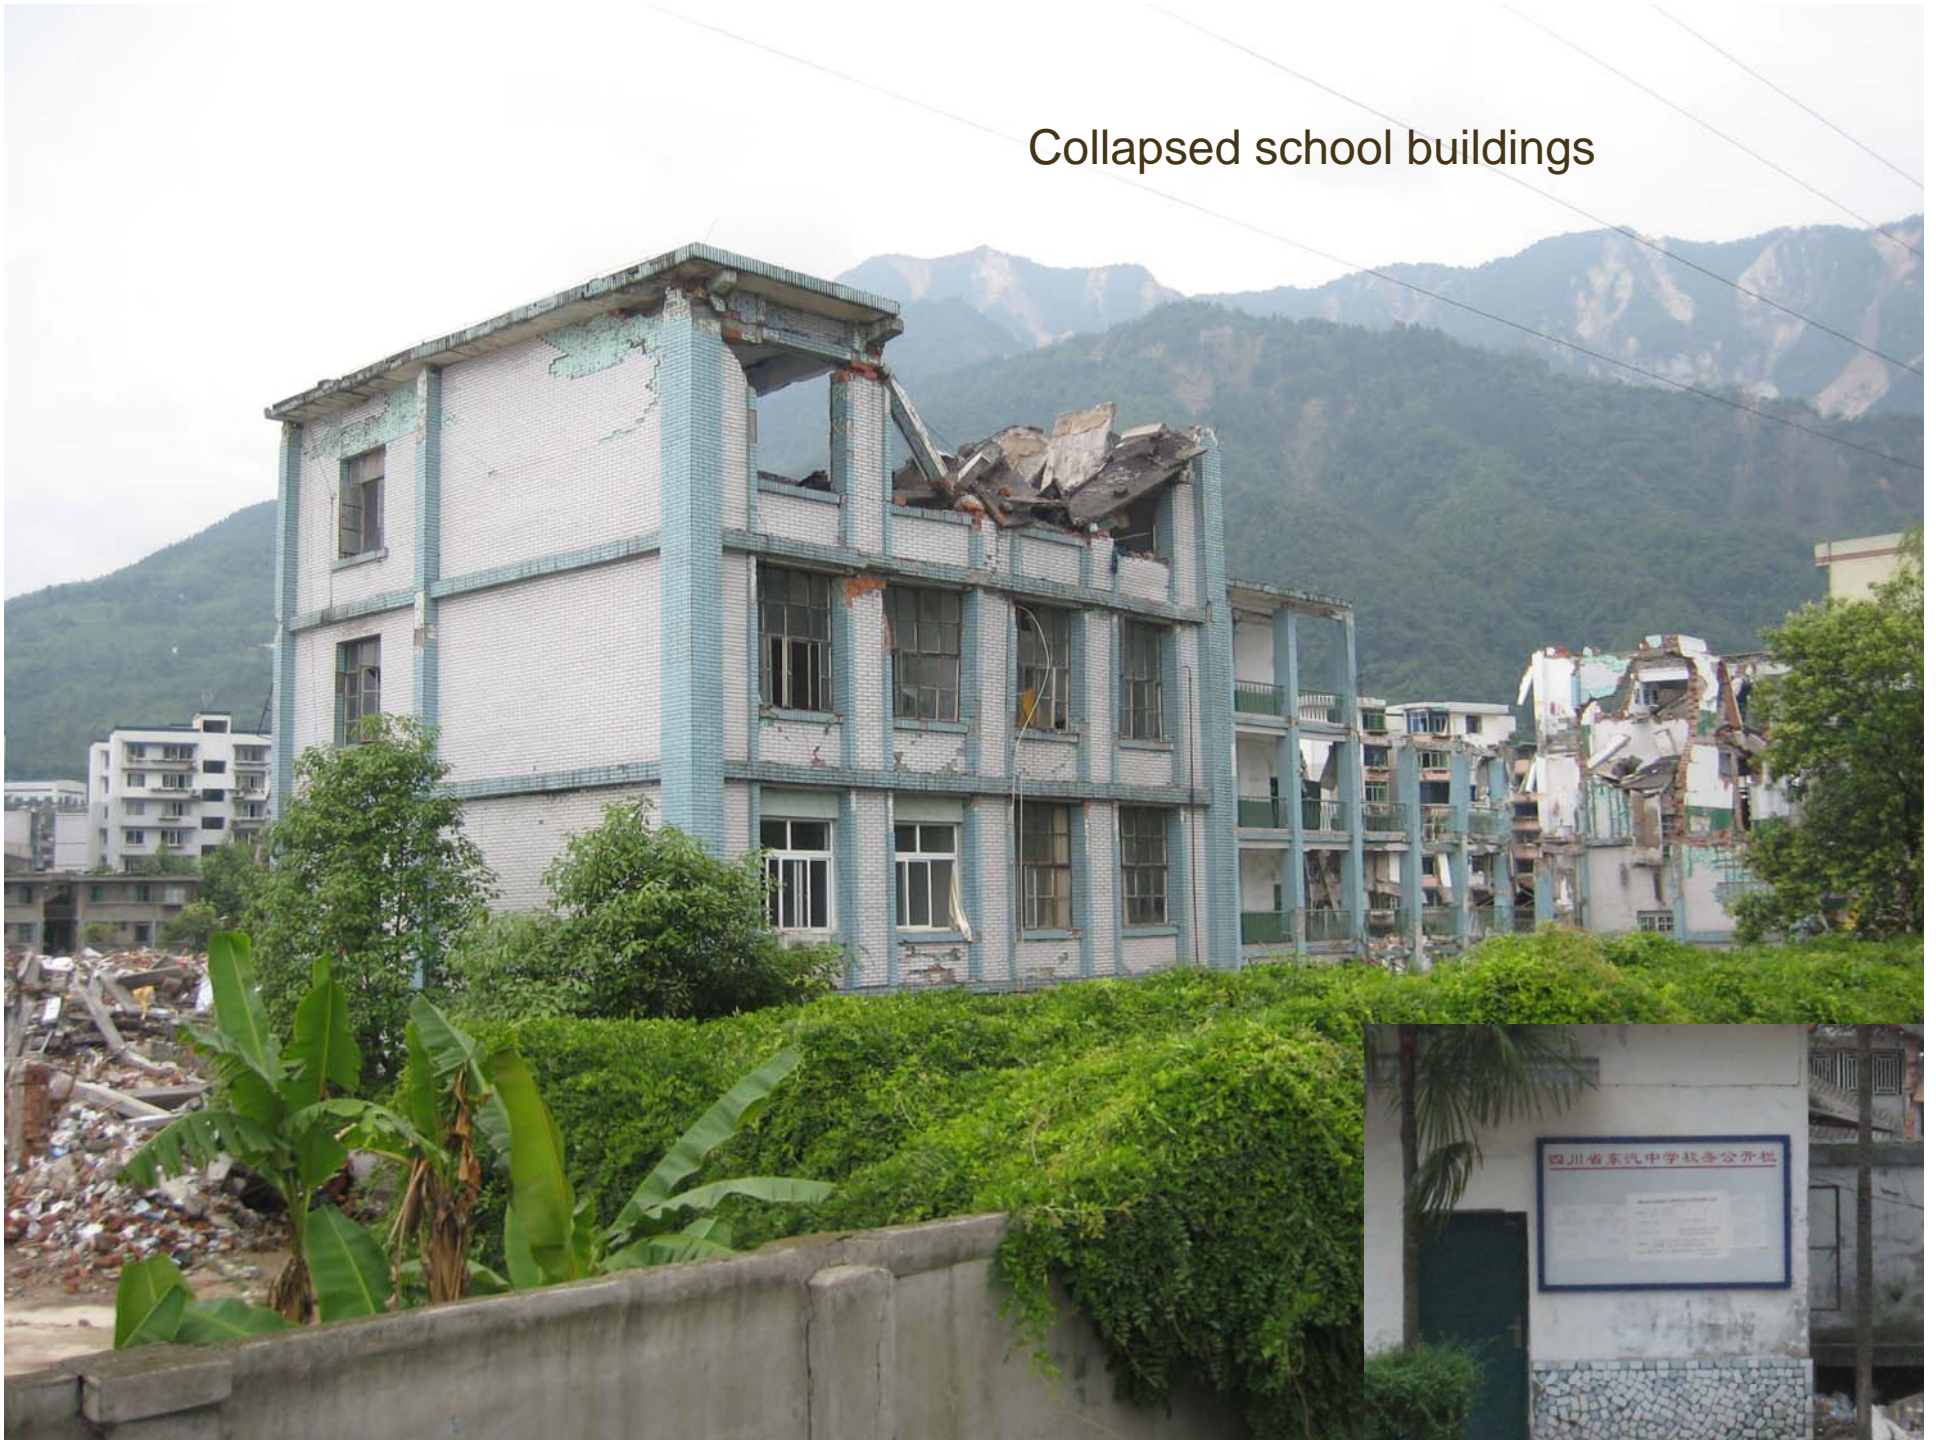
Collapsed school buildings

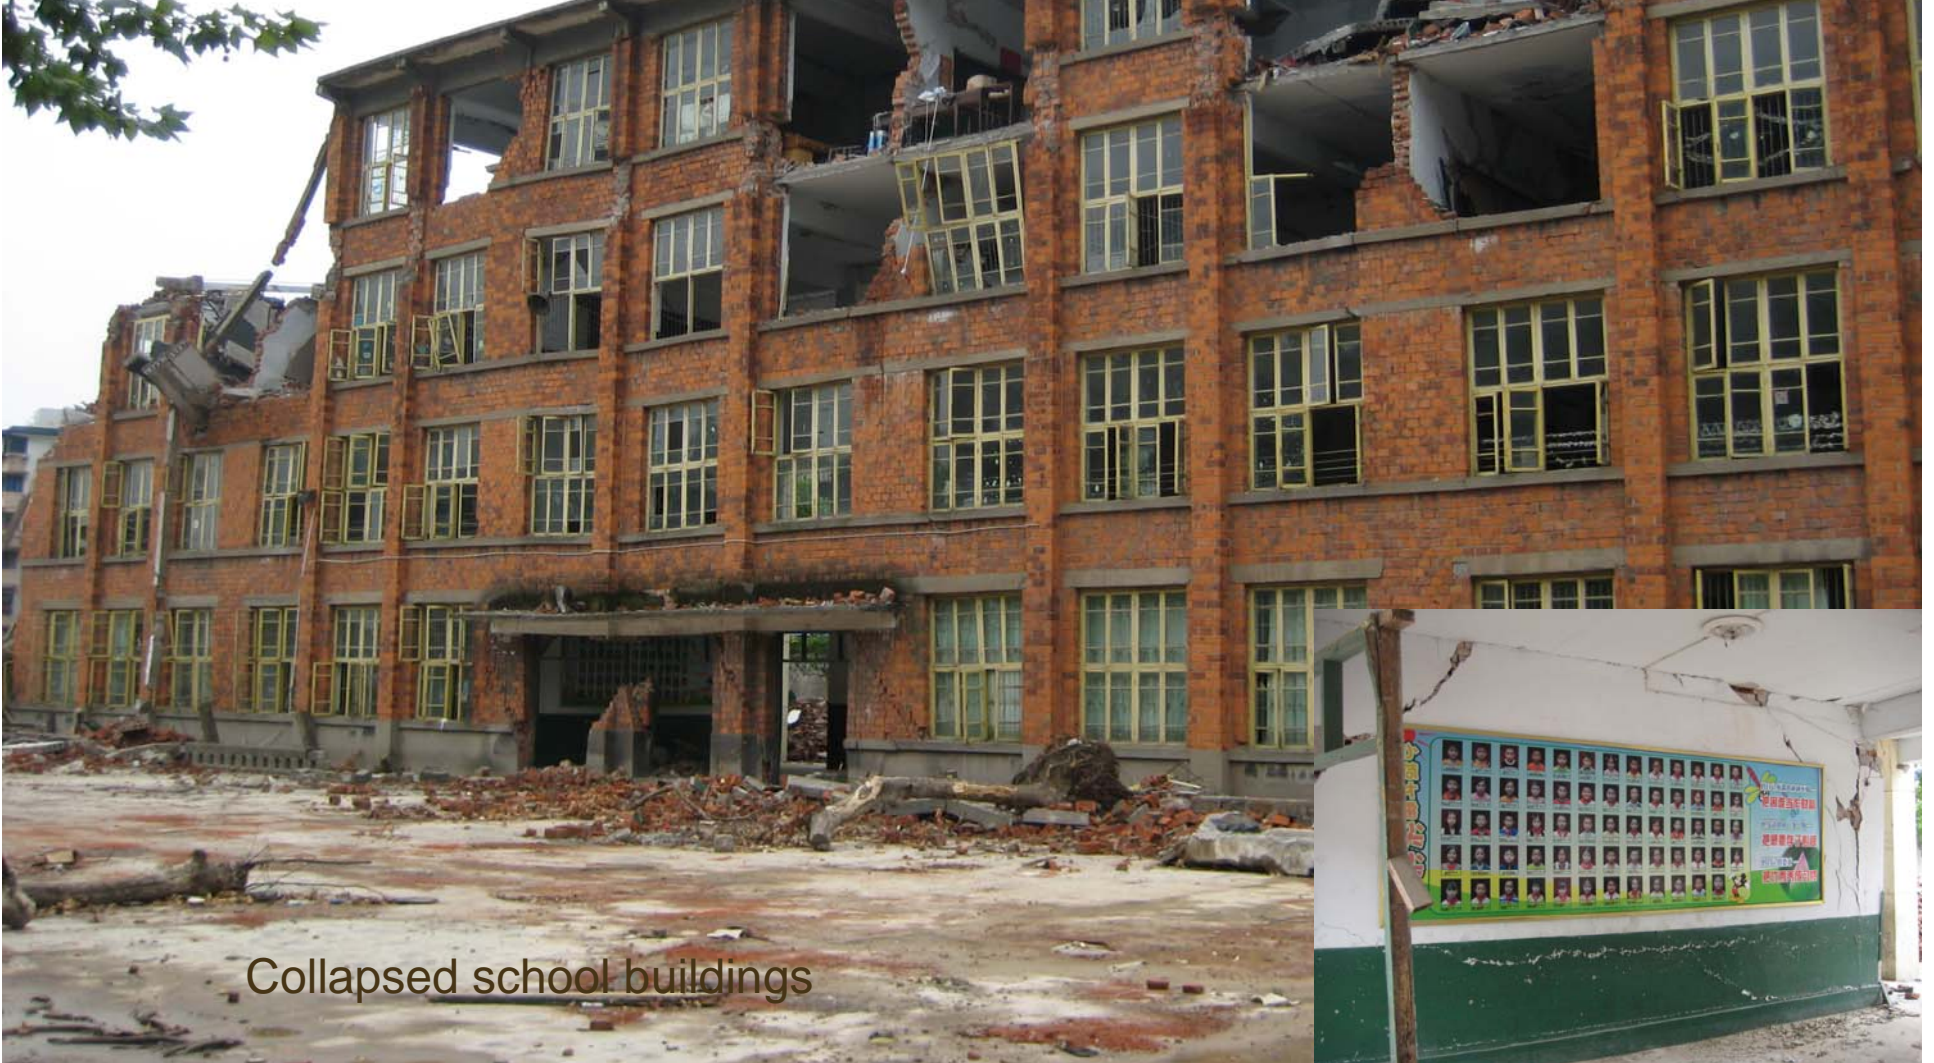
Collapsed school buildings

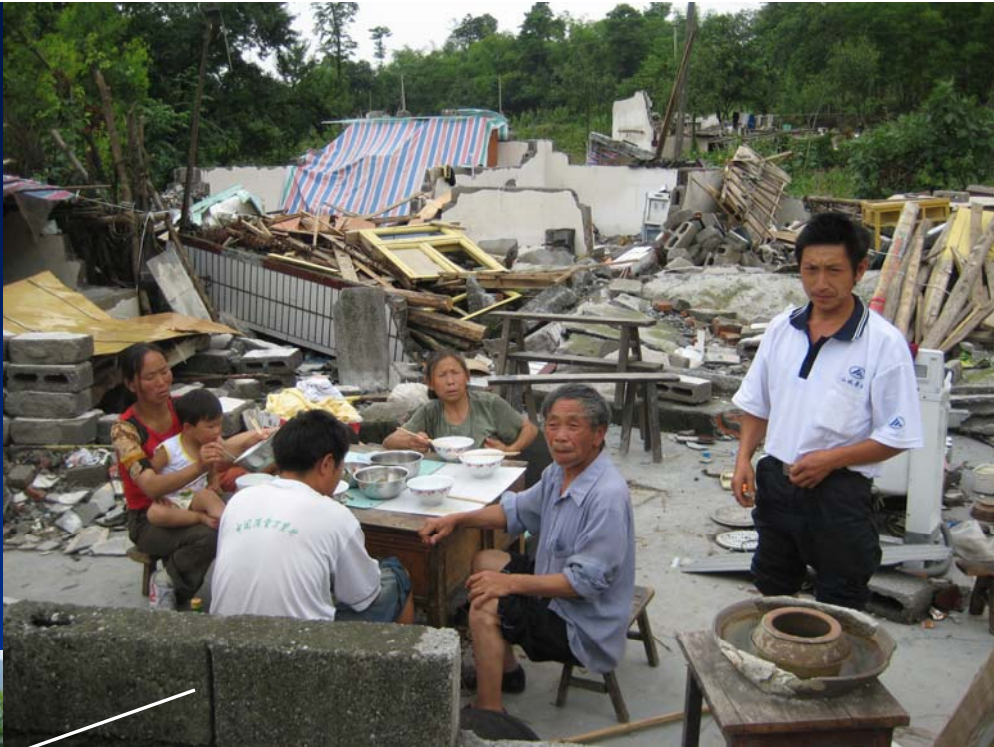
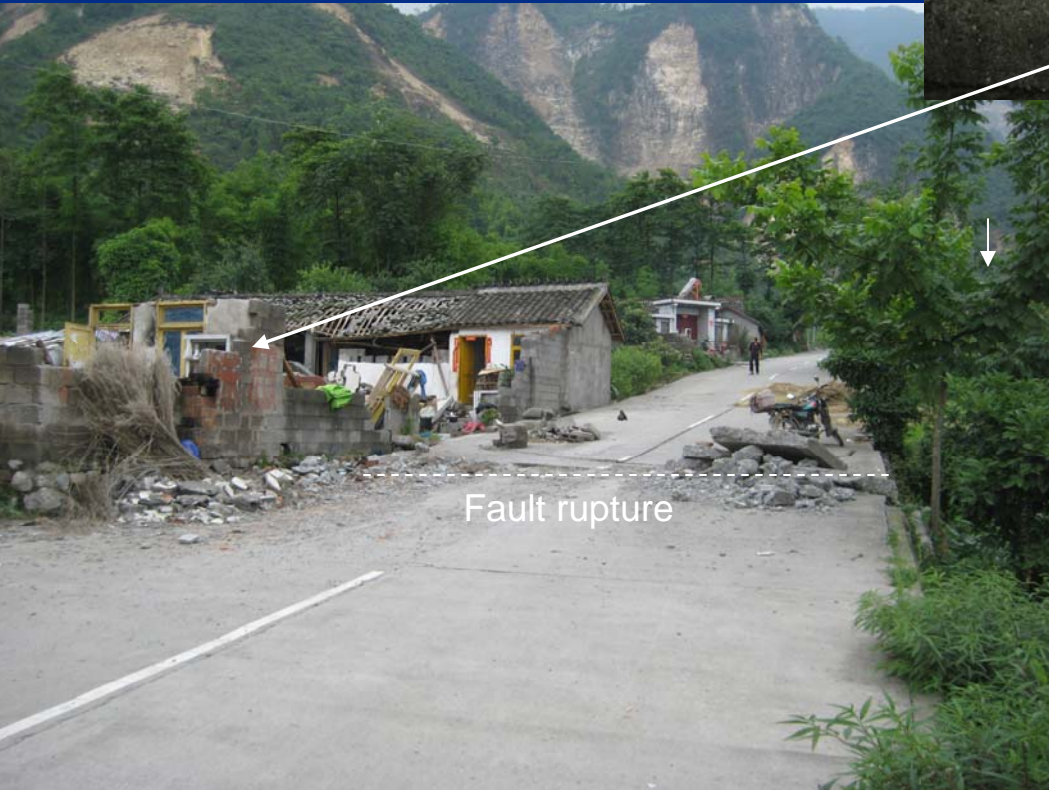
Family lunch on top of ruptured fault

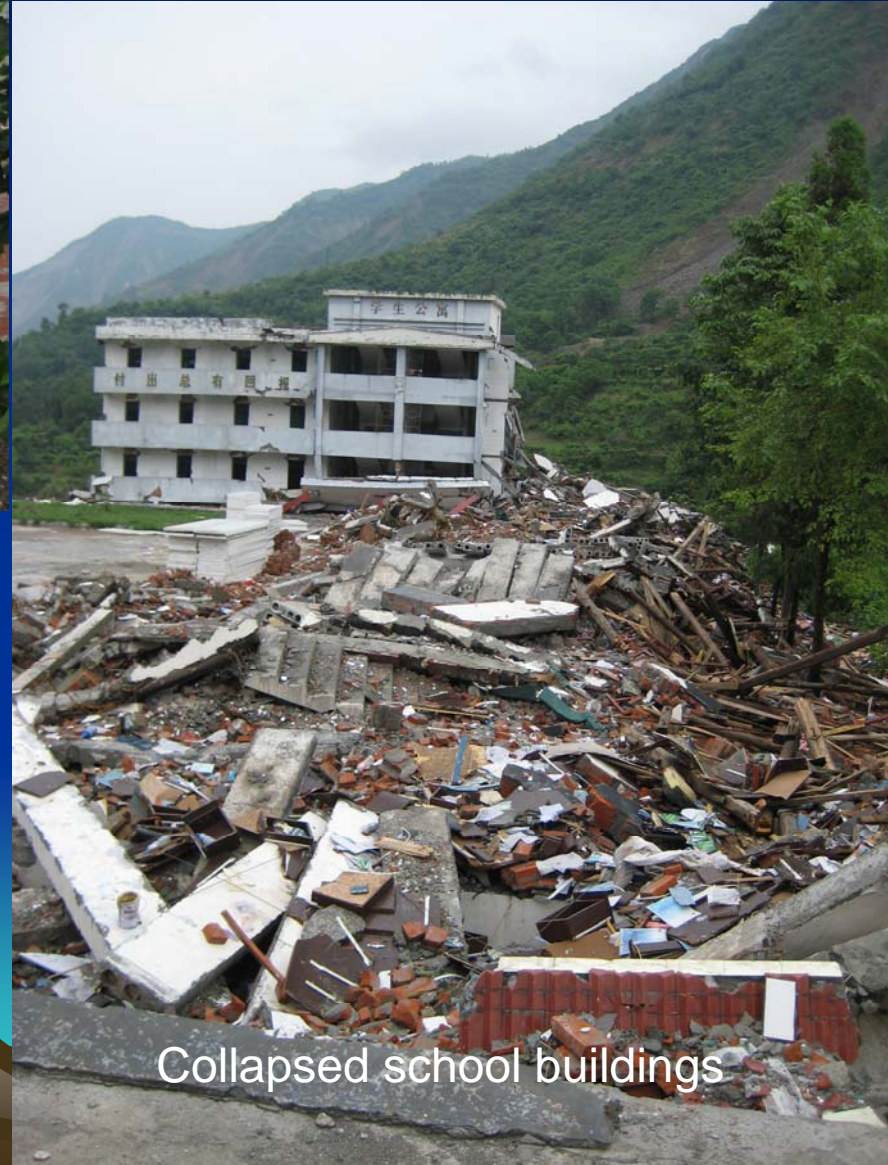
100+ students were killed

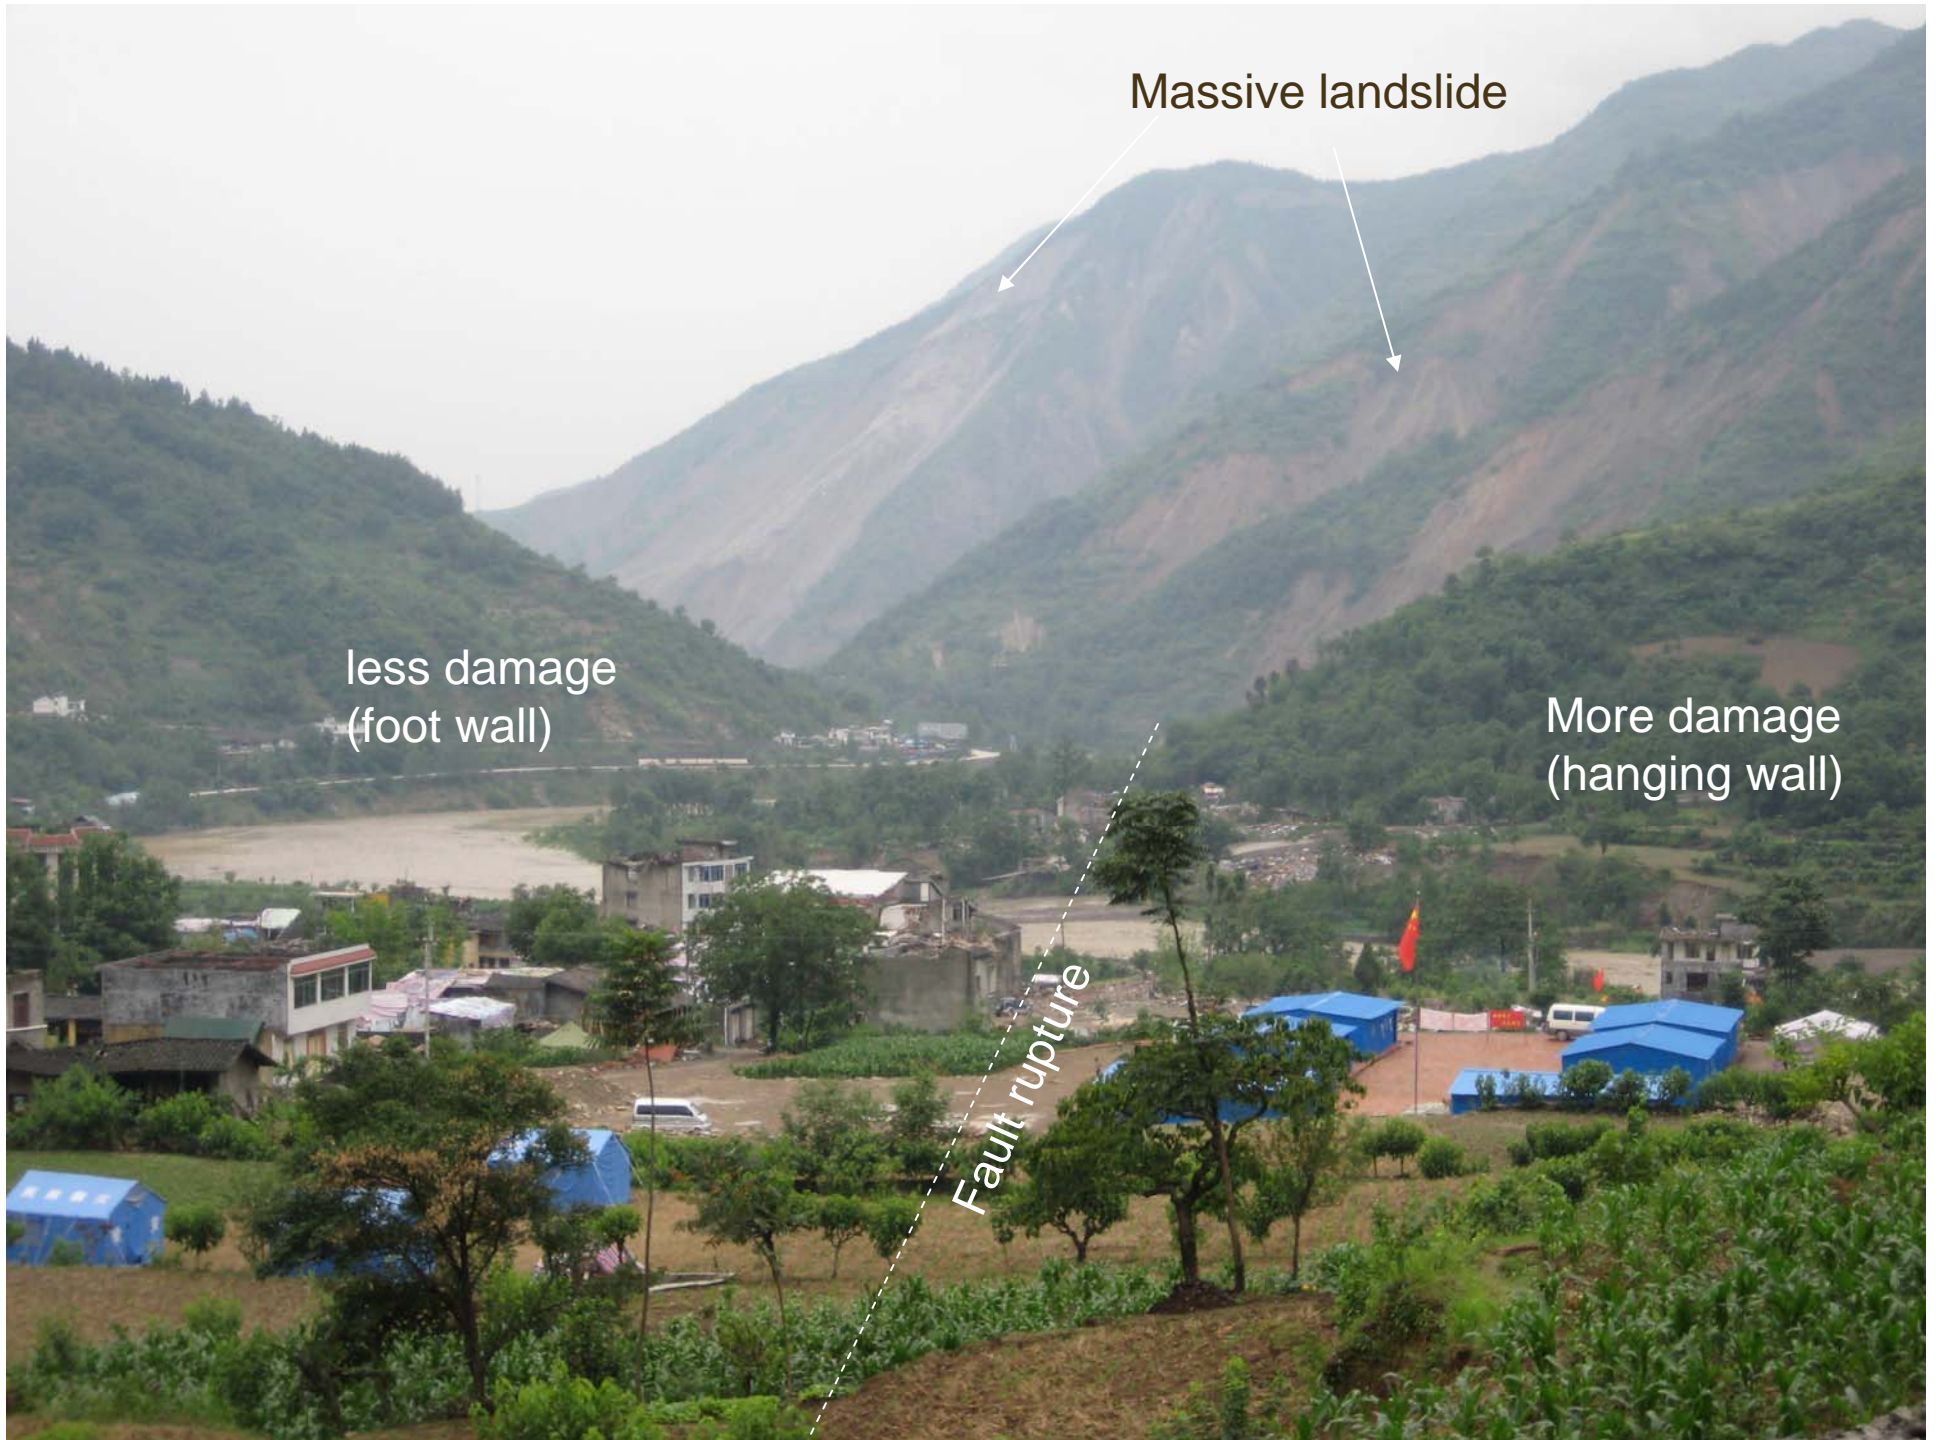
Massive landslide

less damage  
(foot wall)

More damage  
(hanging wall)

Fault rupture

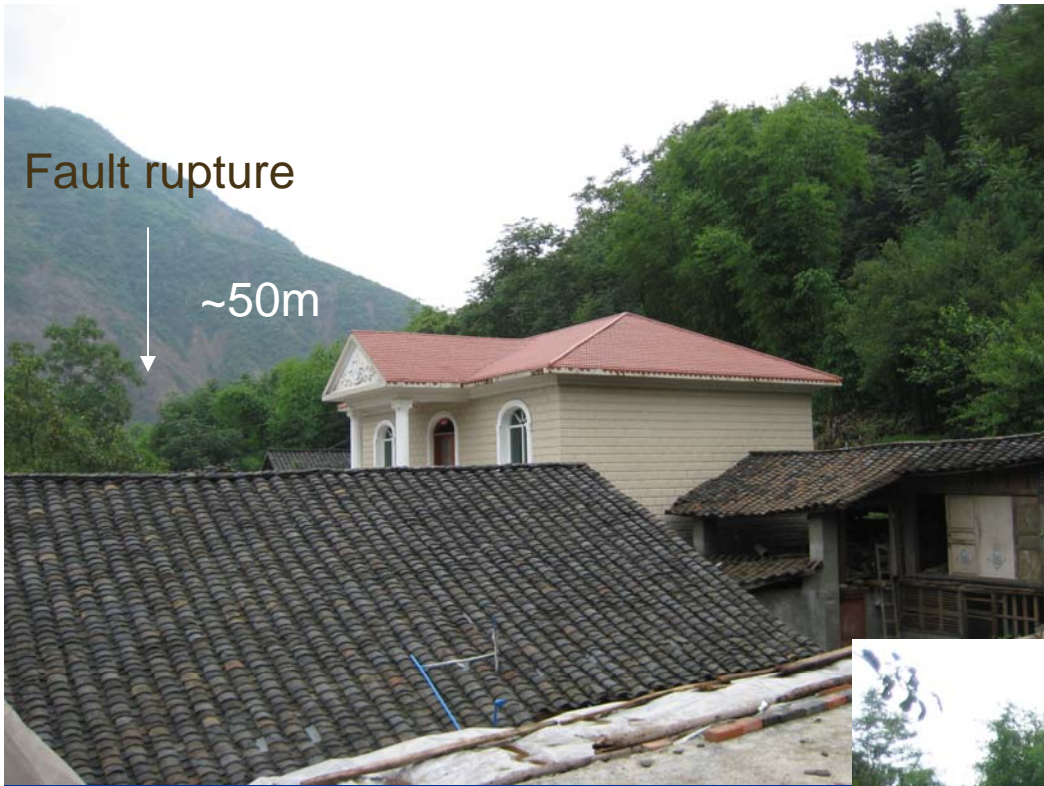
No damage to this house  
(about 50 m from the rupture)

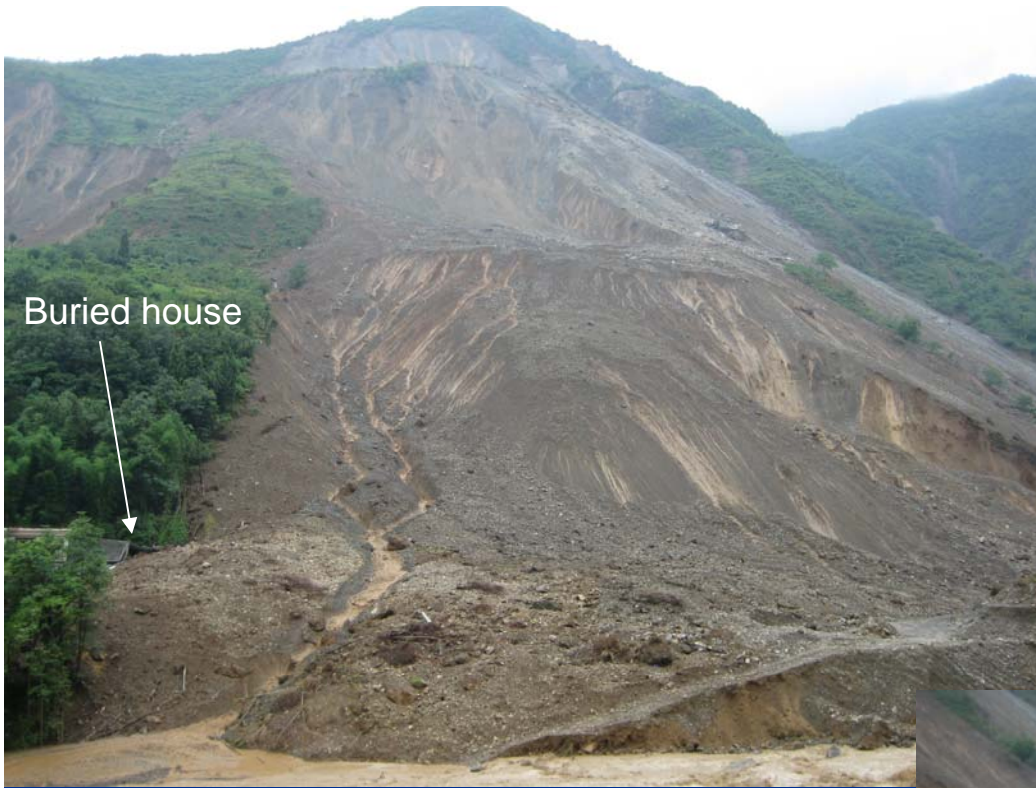
Large landslide

60+ people were buried

Buried houses

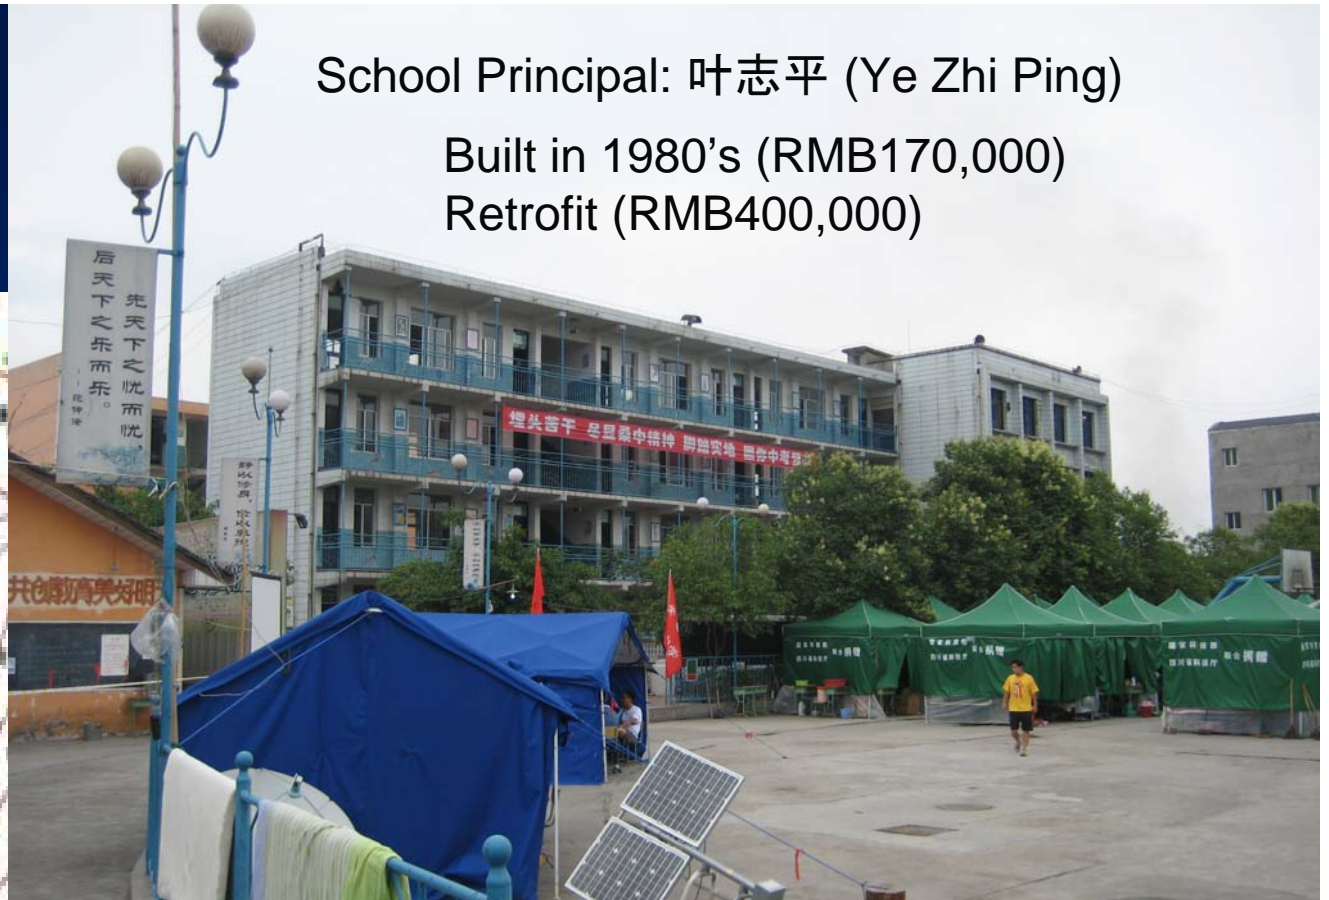
Shan Zhao Middle School

Built in 1980's (RMB170,000)

Retrofit (RMB400,000)

All evacuated in 2 minutes after EQ  
2,200 students with no single injury
