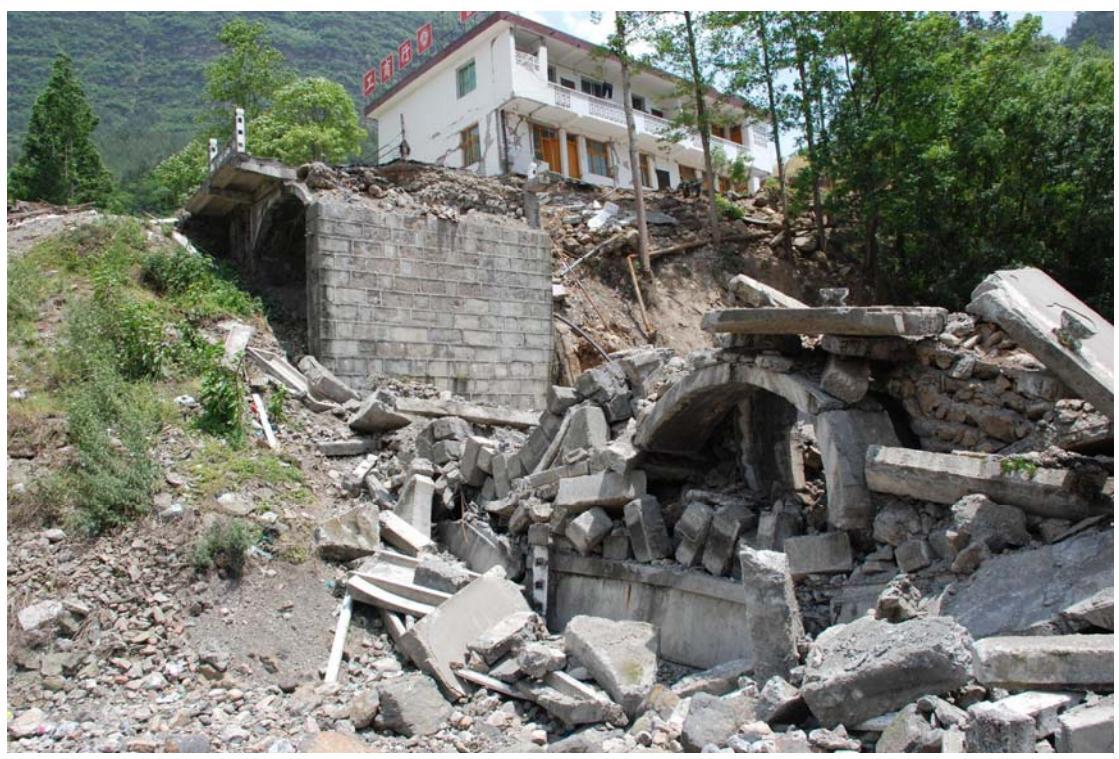
Collapsed arch bridge

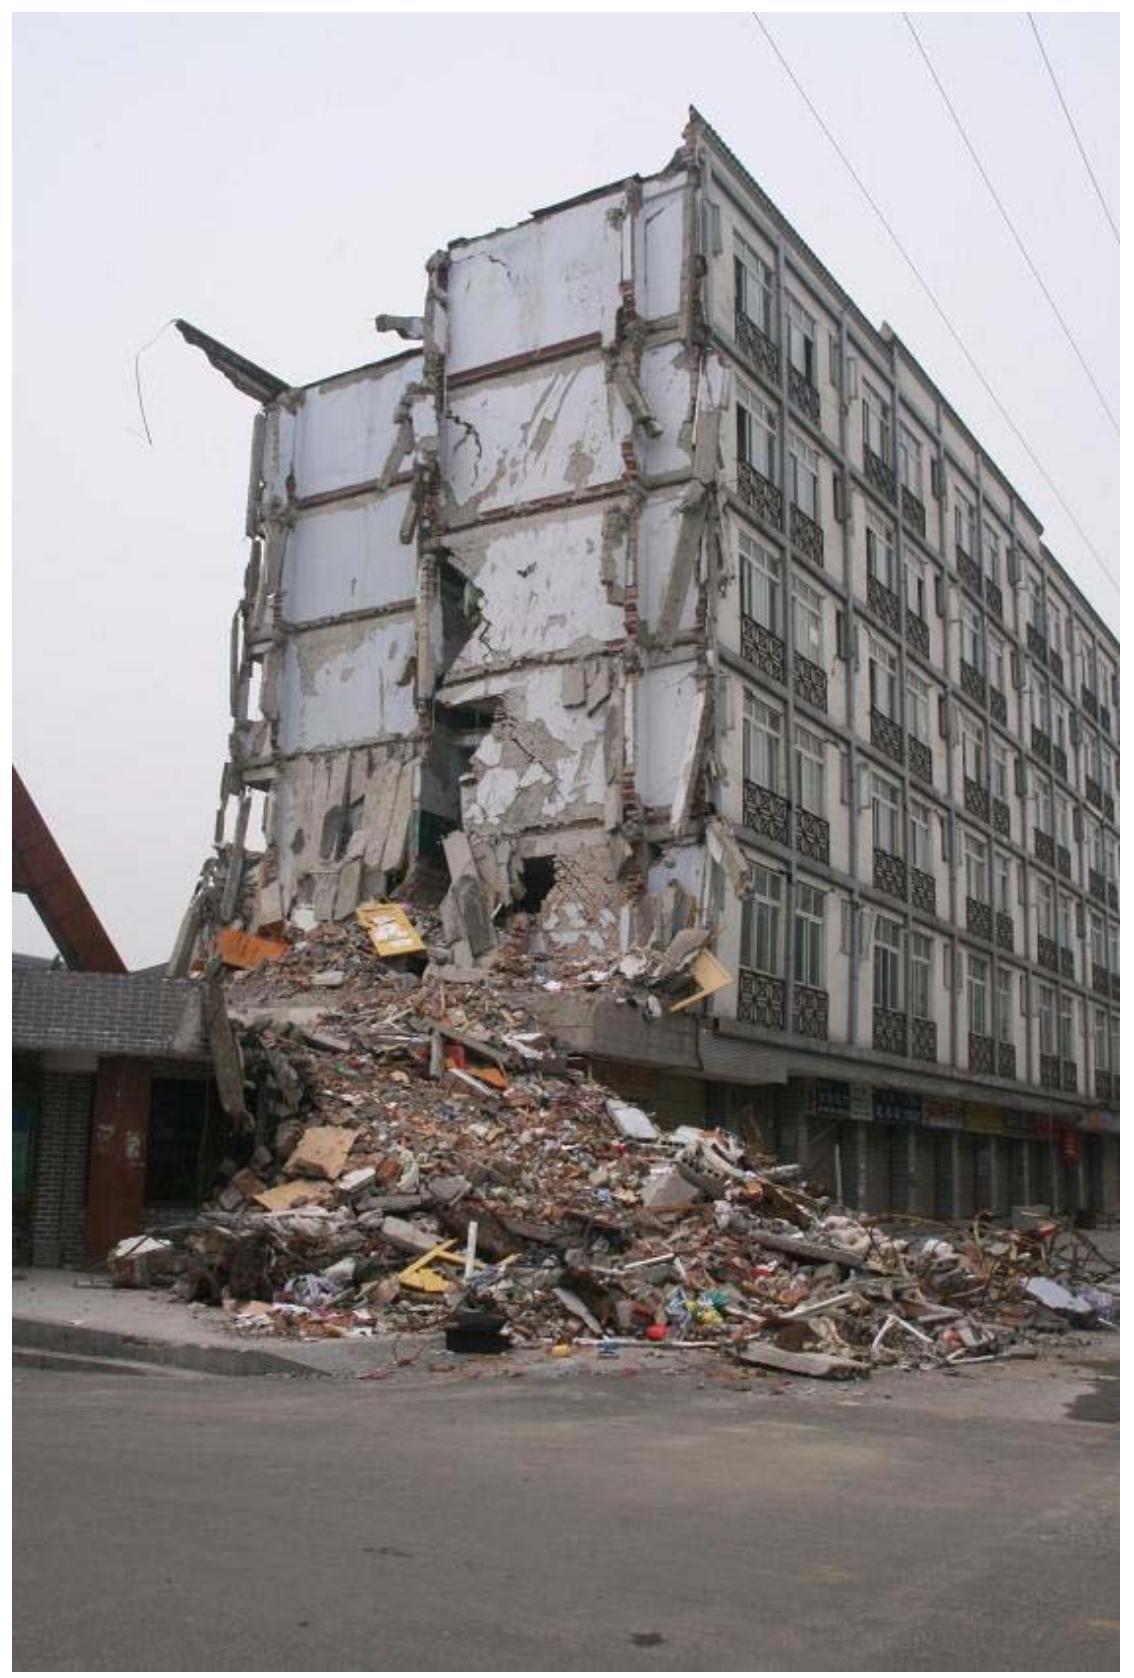
Collapsed building in Dujiangyan

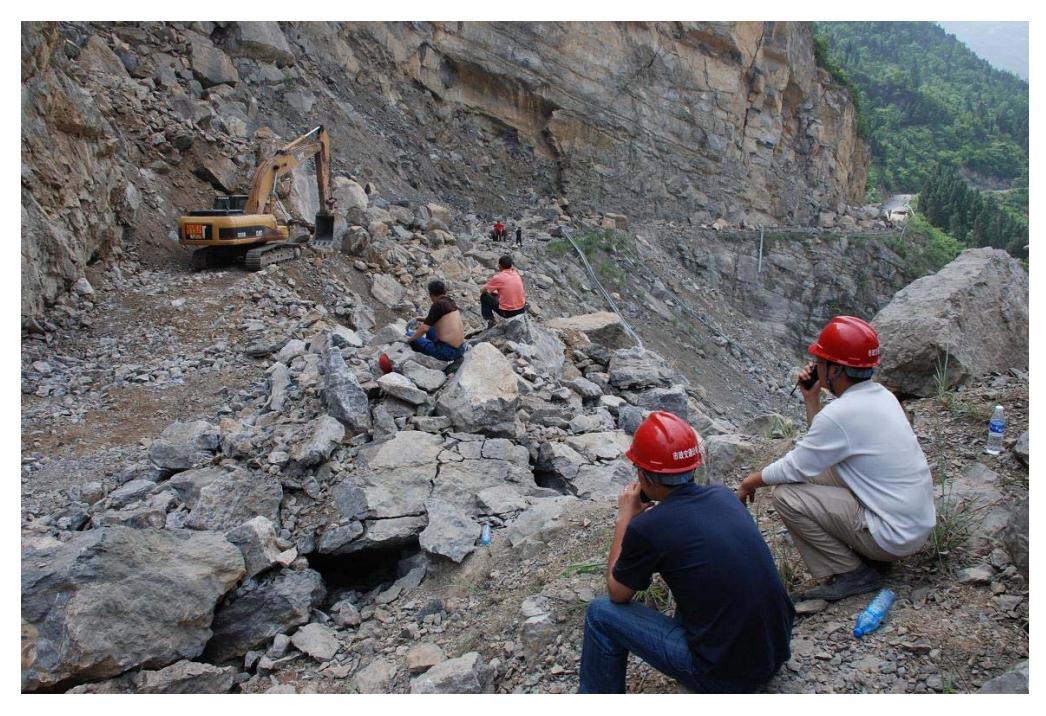
Dangerous and slow process in recovering the damaged mountain highway

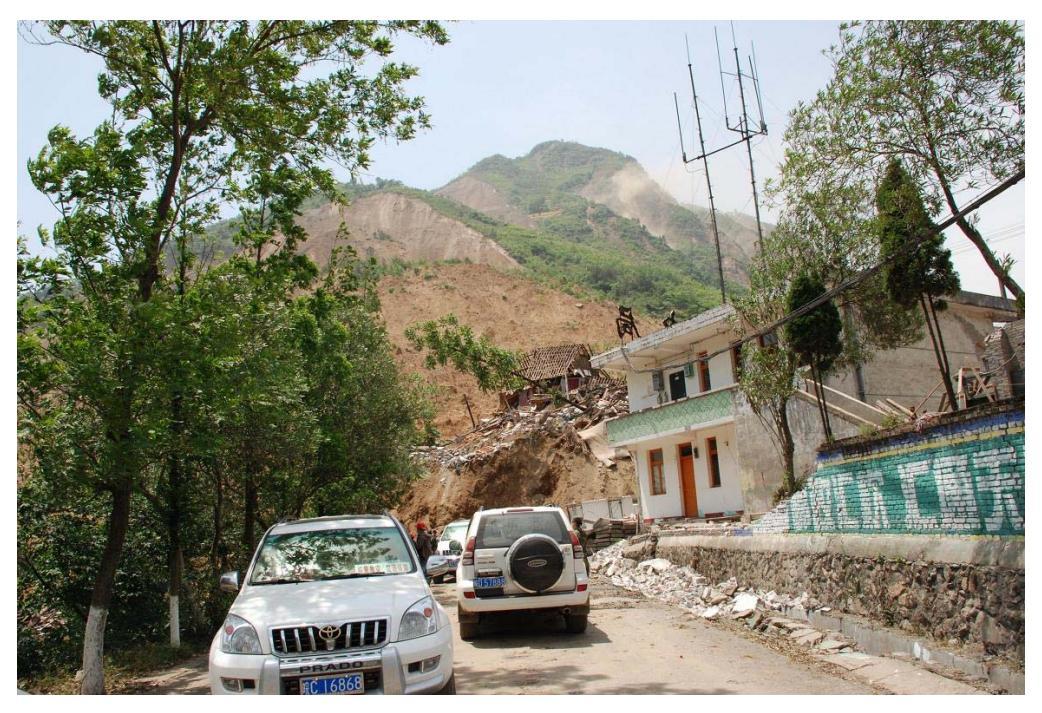
Mountain slope failure in Beichuan

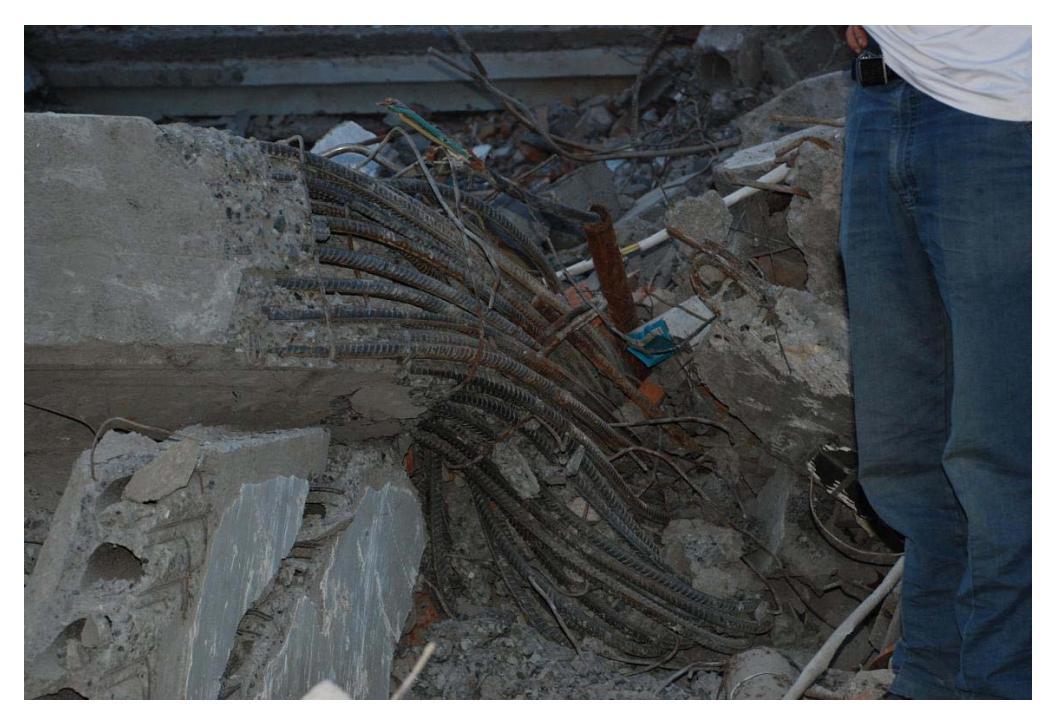
From the reconnaissance of the earthquake damage, it is clear that most of the damaged concrete building columns, and beam to column joints did not have proper transverse reinforcement.

Poor design with too many longitudinal bars but little transverse bars
