Marvin Blan #1 Image Log Report

(as conducted by Ray Reid)

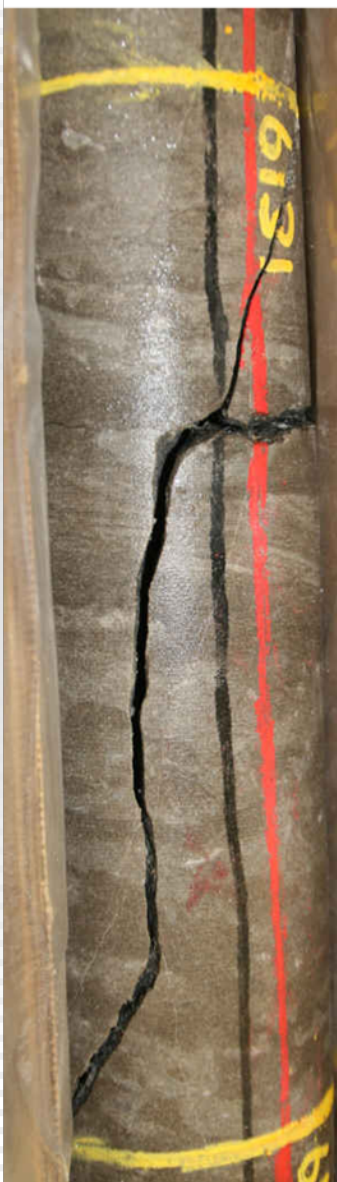
Fracture in core as  
seen on image log
