***May 12, 2008 Sichuan, China  
Earthquake Reconnaissance***

Zhenming Wang  
Kentucky Geological Survey  
228 MMRB

July 2008

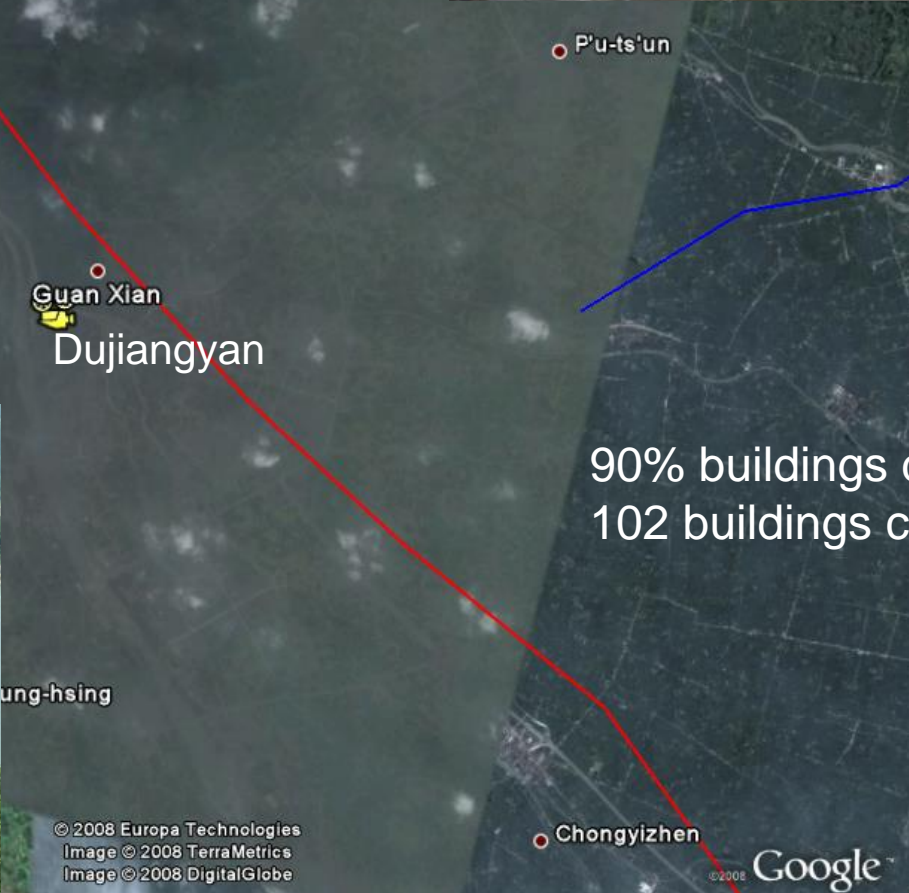
90% buildings damaged  
102 buildings collapsed

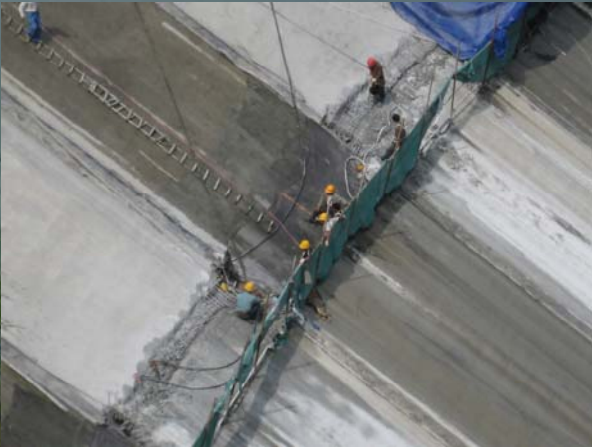
Water level before earthquake

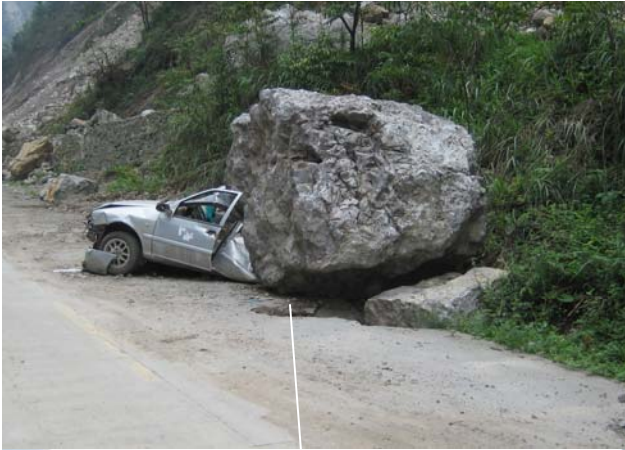
Dangerous road

Damaged bridge

Lateral spreading

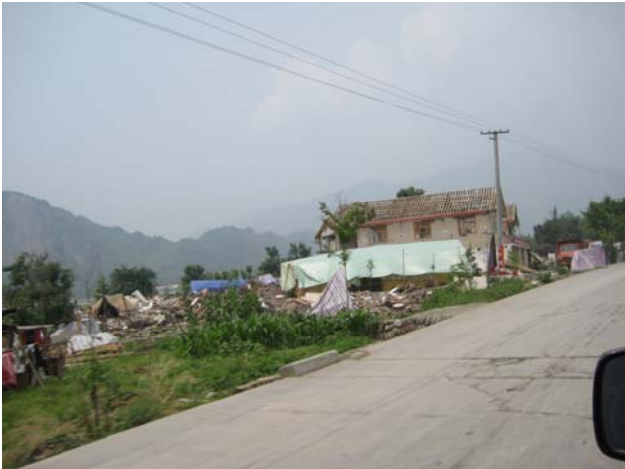
Collapsed and severe damaged houses in this area

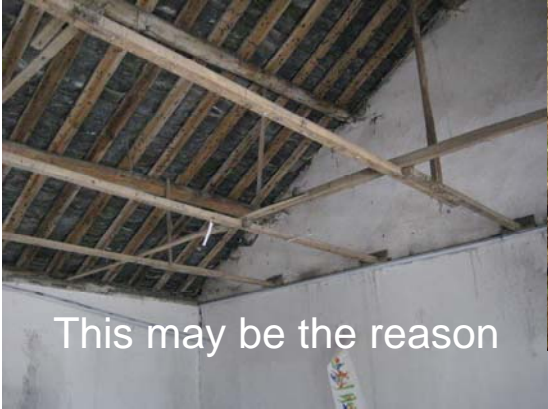
This may be the reason

Rupture

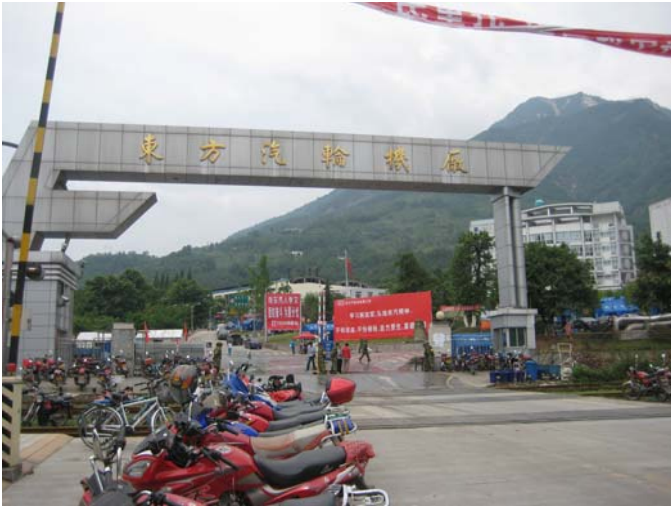
Collapsed school buildings

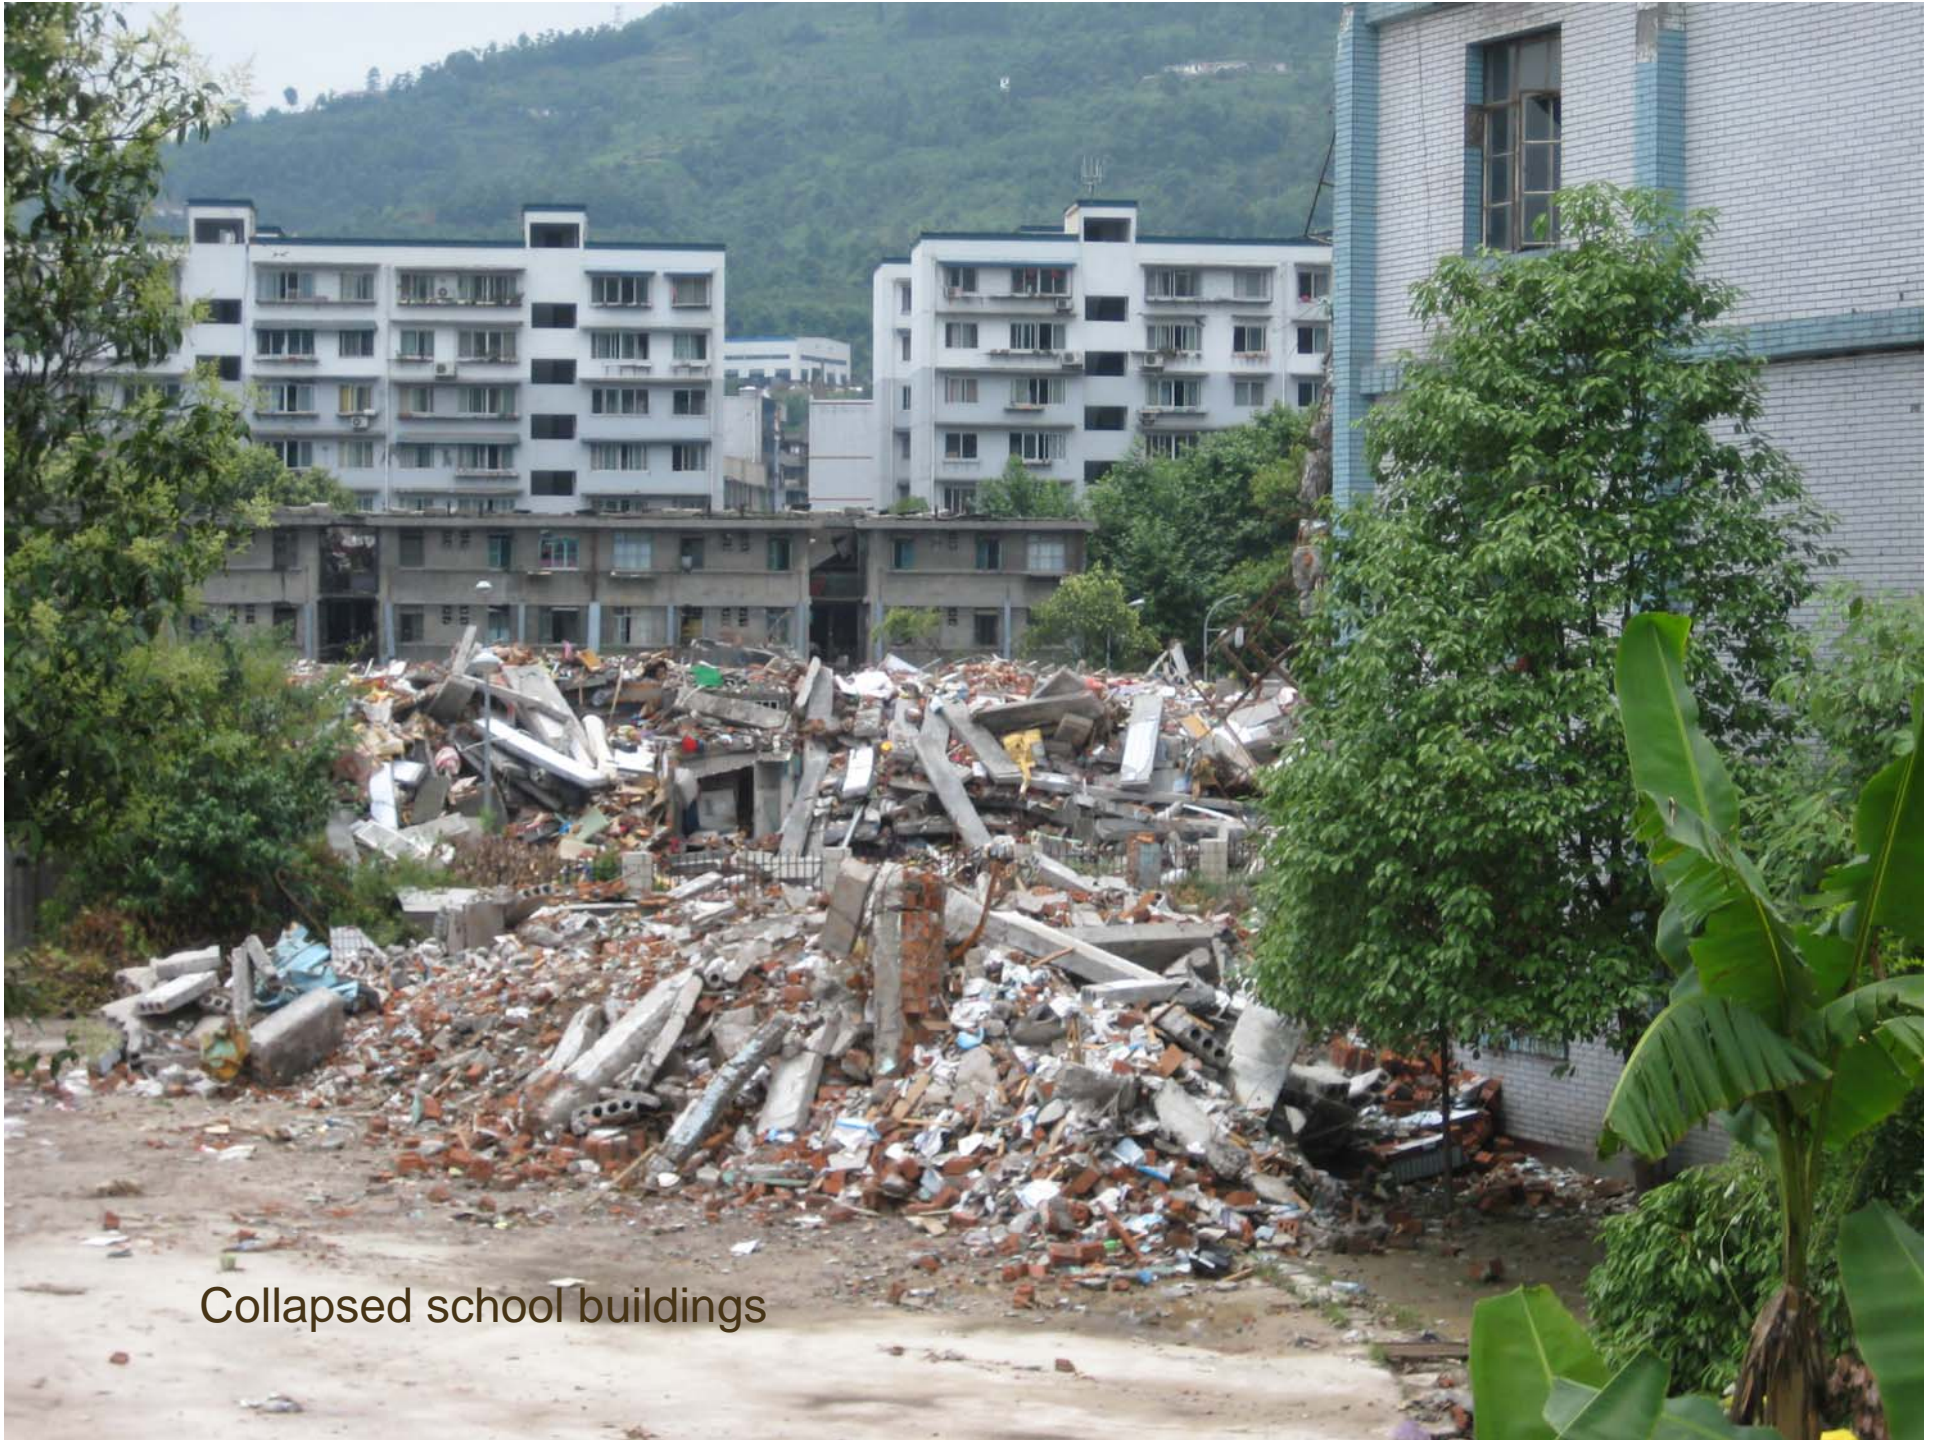
Collapsed school buildings

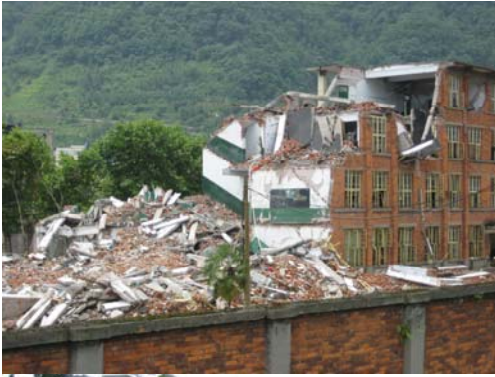
Collapsed school buildings

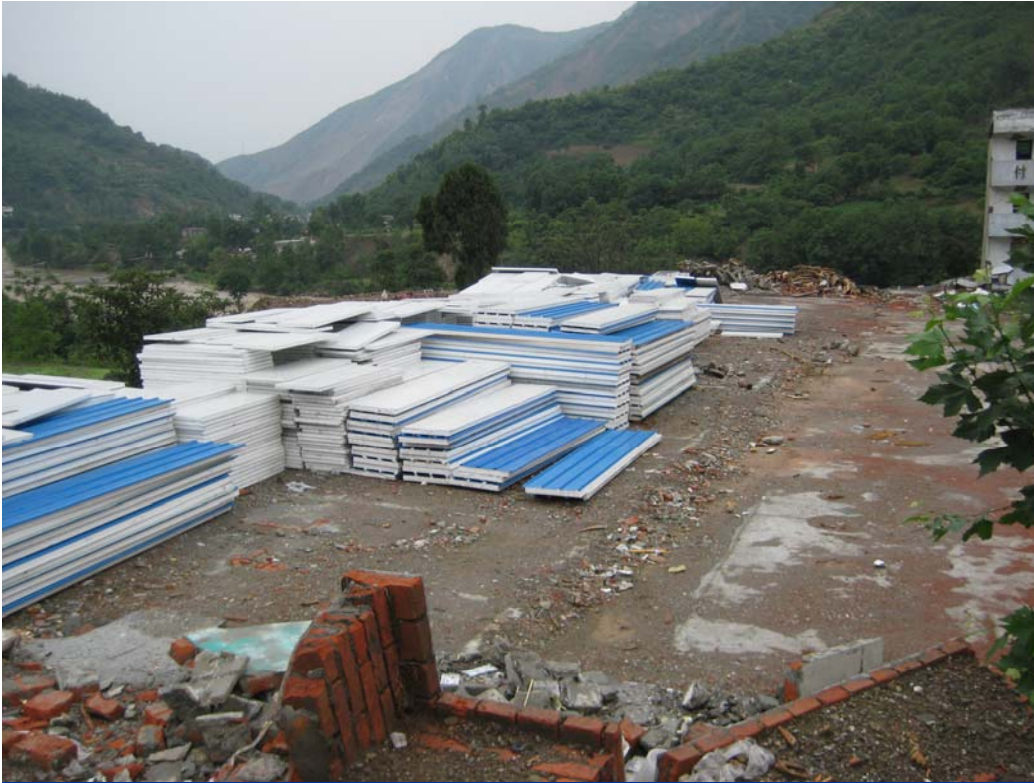
100+ students were killed

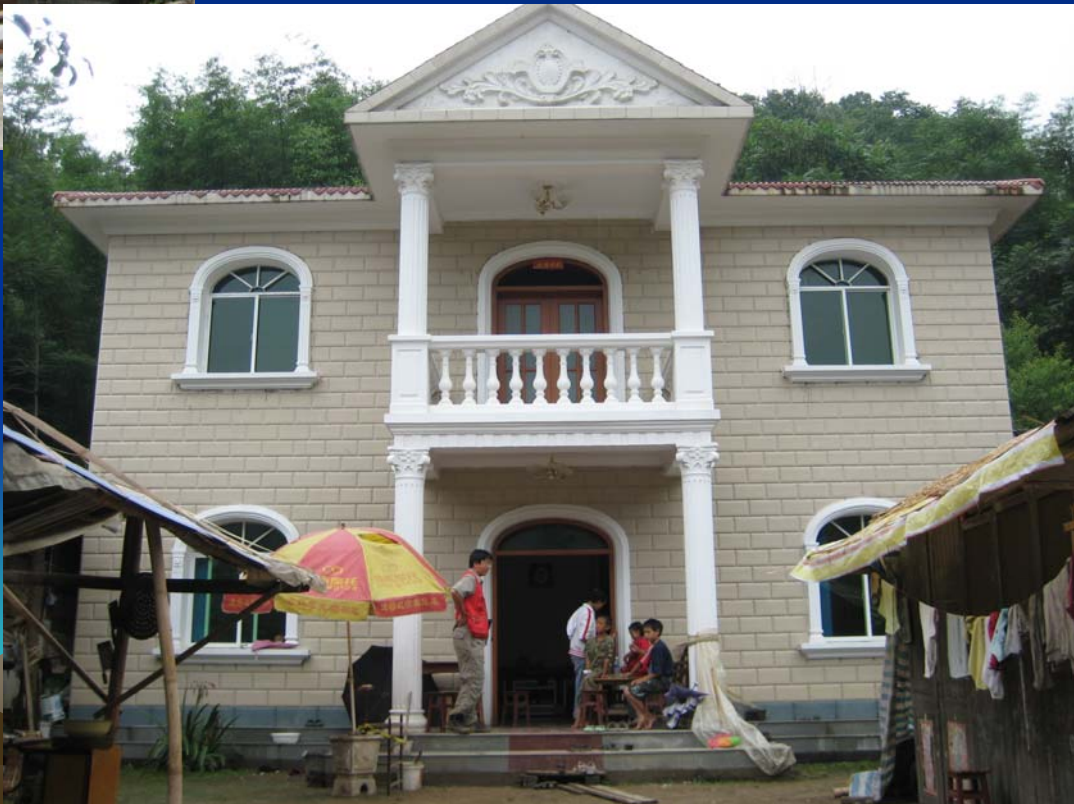
No damage to this house  
(about 50 m from the rupture)

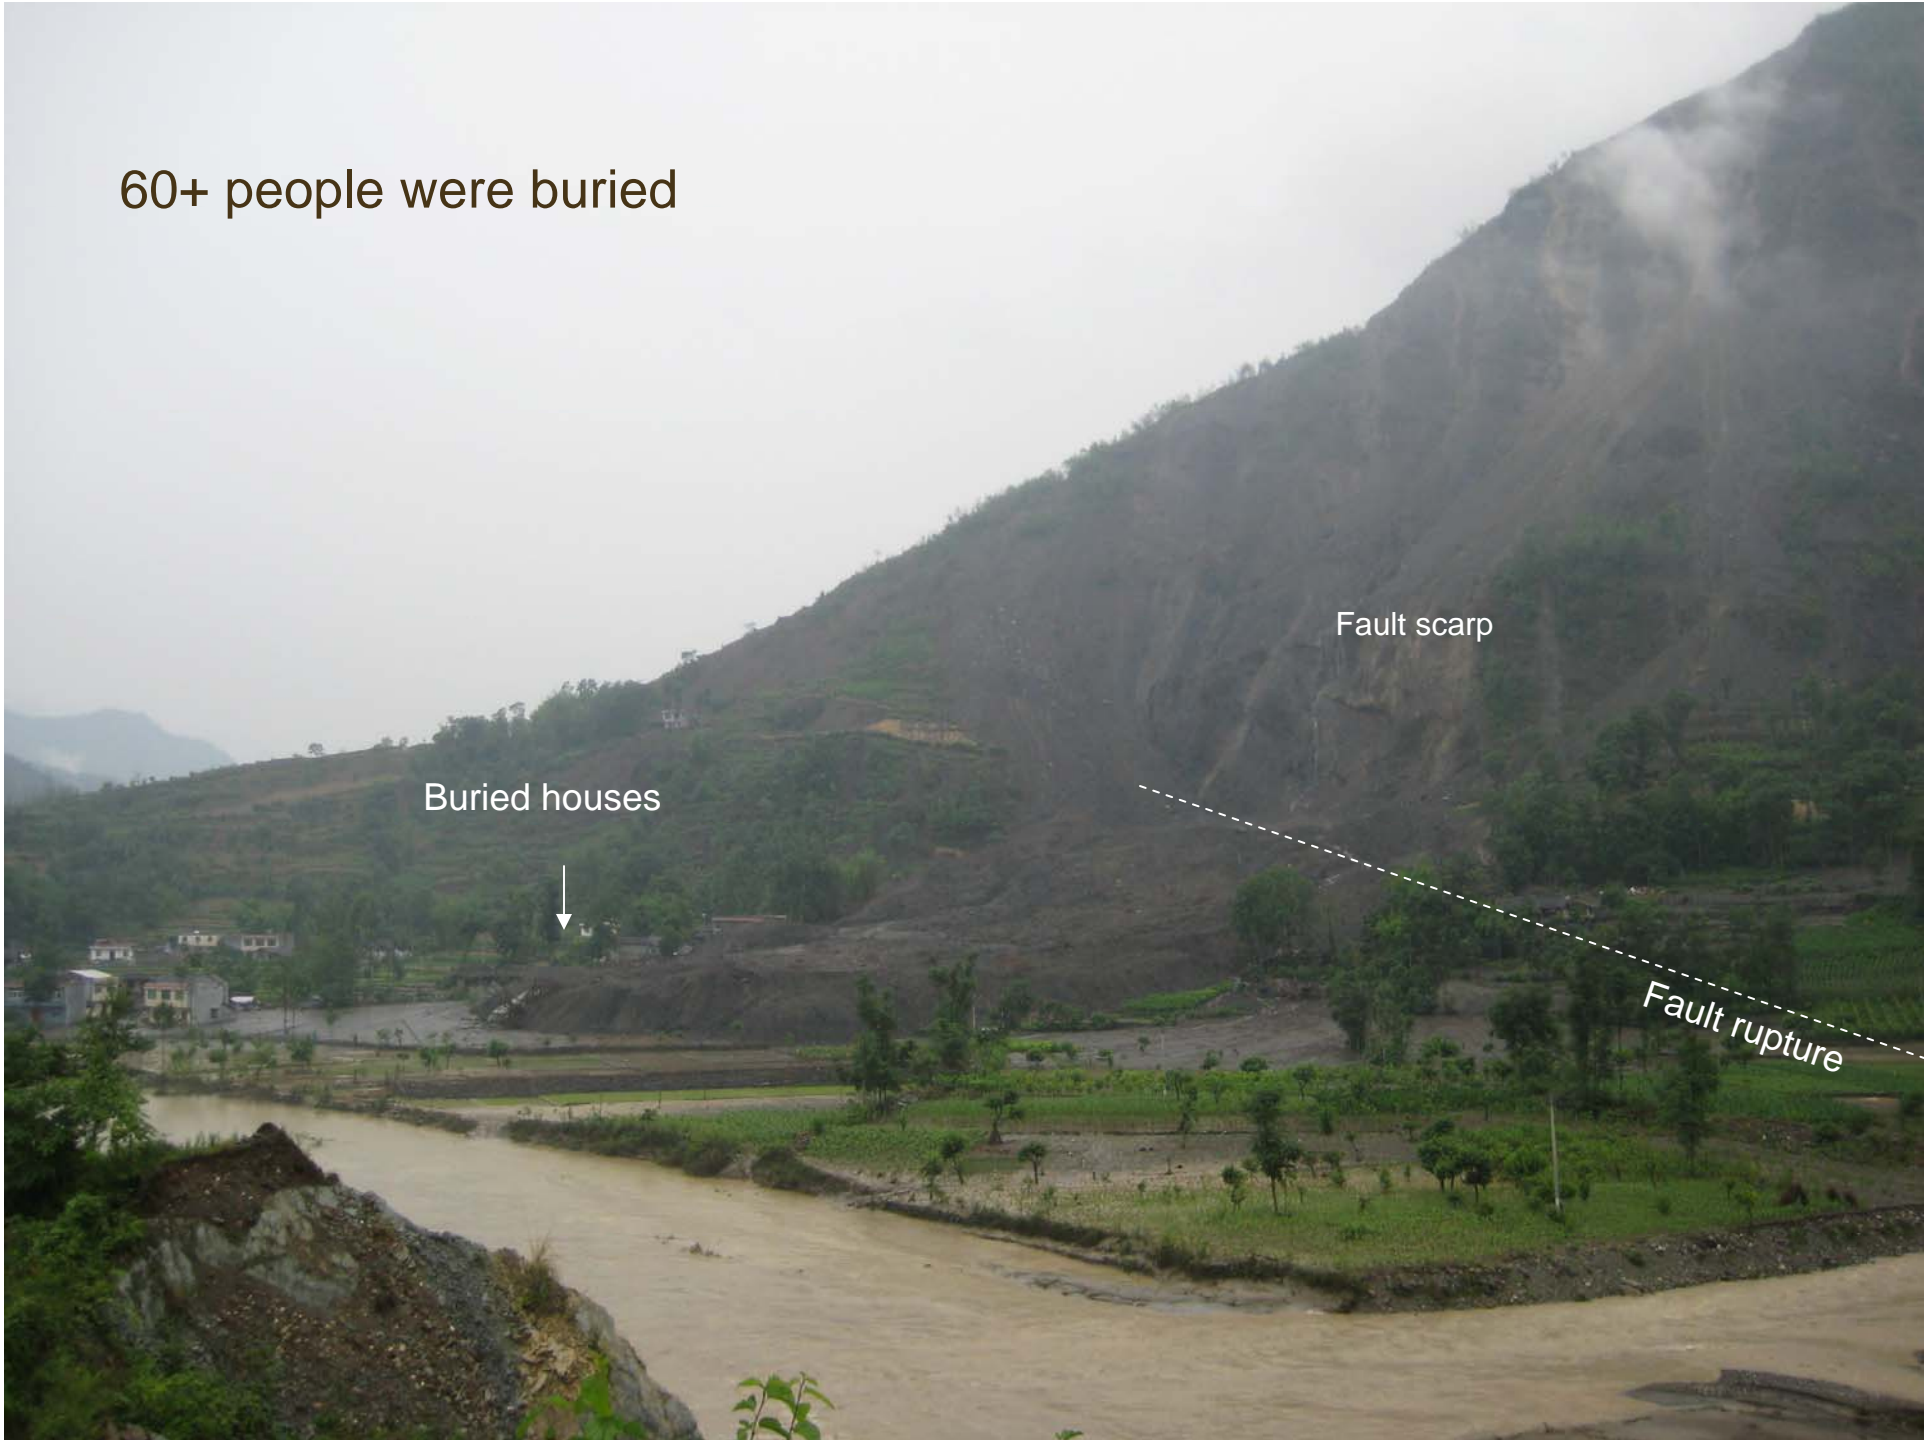
Fault scarp

Fault rupture

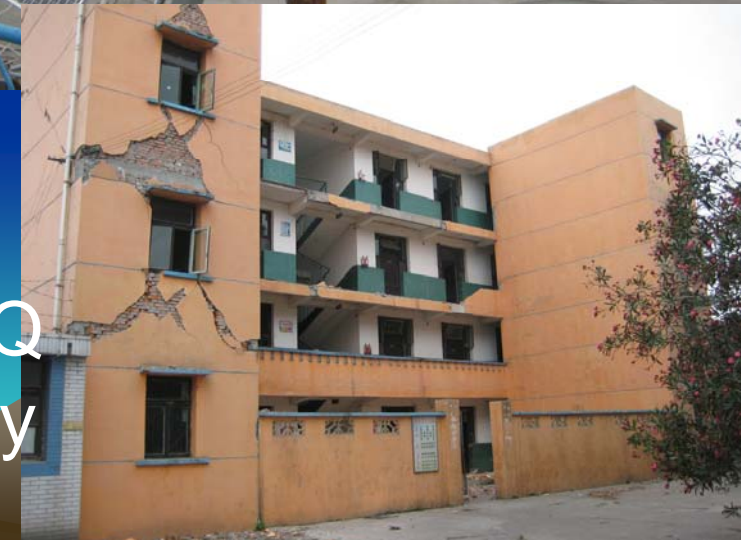
Shan Zhao Middle School

Built in 1980's (RMB170,000)

Retrofit (RMB400,000)

All evacuated in 2 minutes after EQ  
2,200 students with no single injury
